Cut Slope Soil Erosion Control Trial

CAP Site 1: REPORT SUMMARY

EOS Ecology Report No. CHR01-20077-03 | November 2022

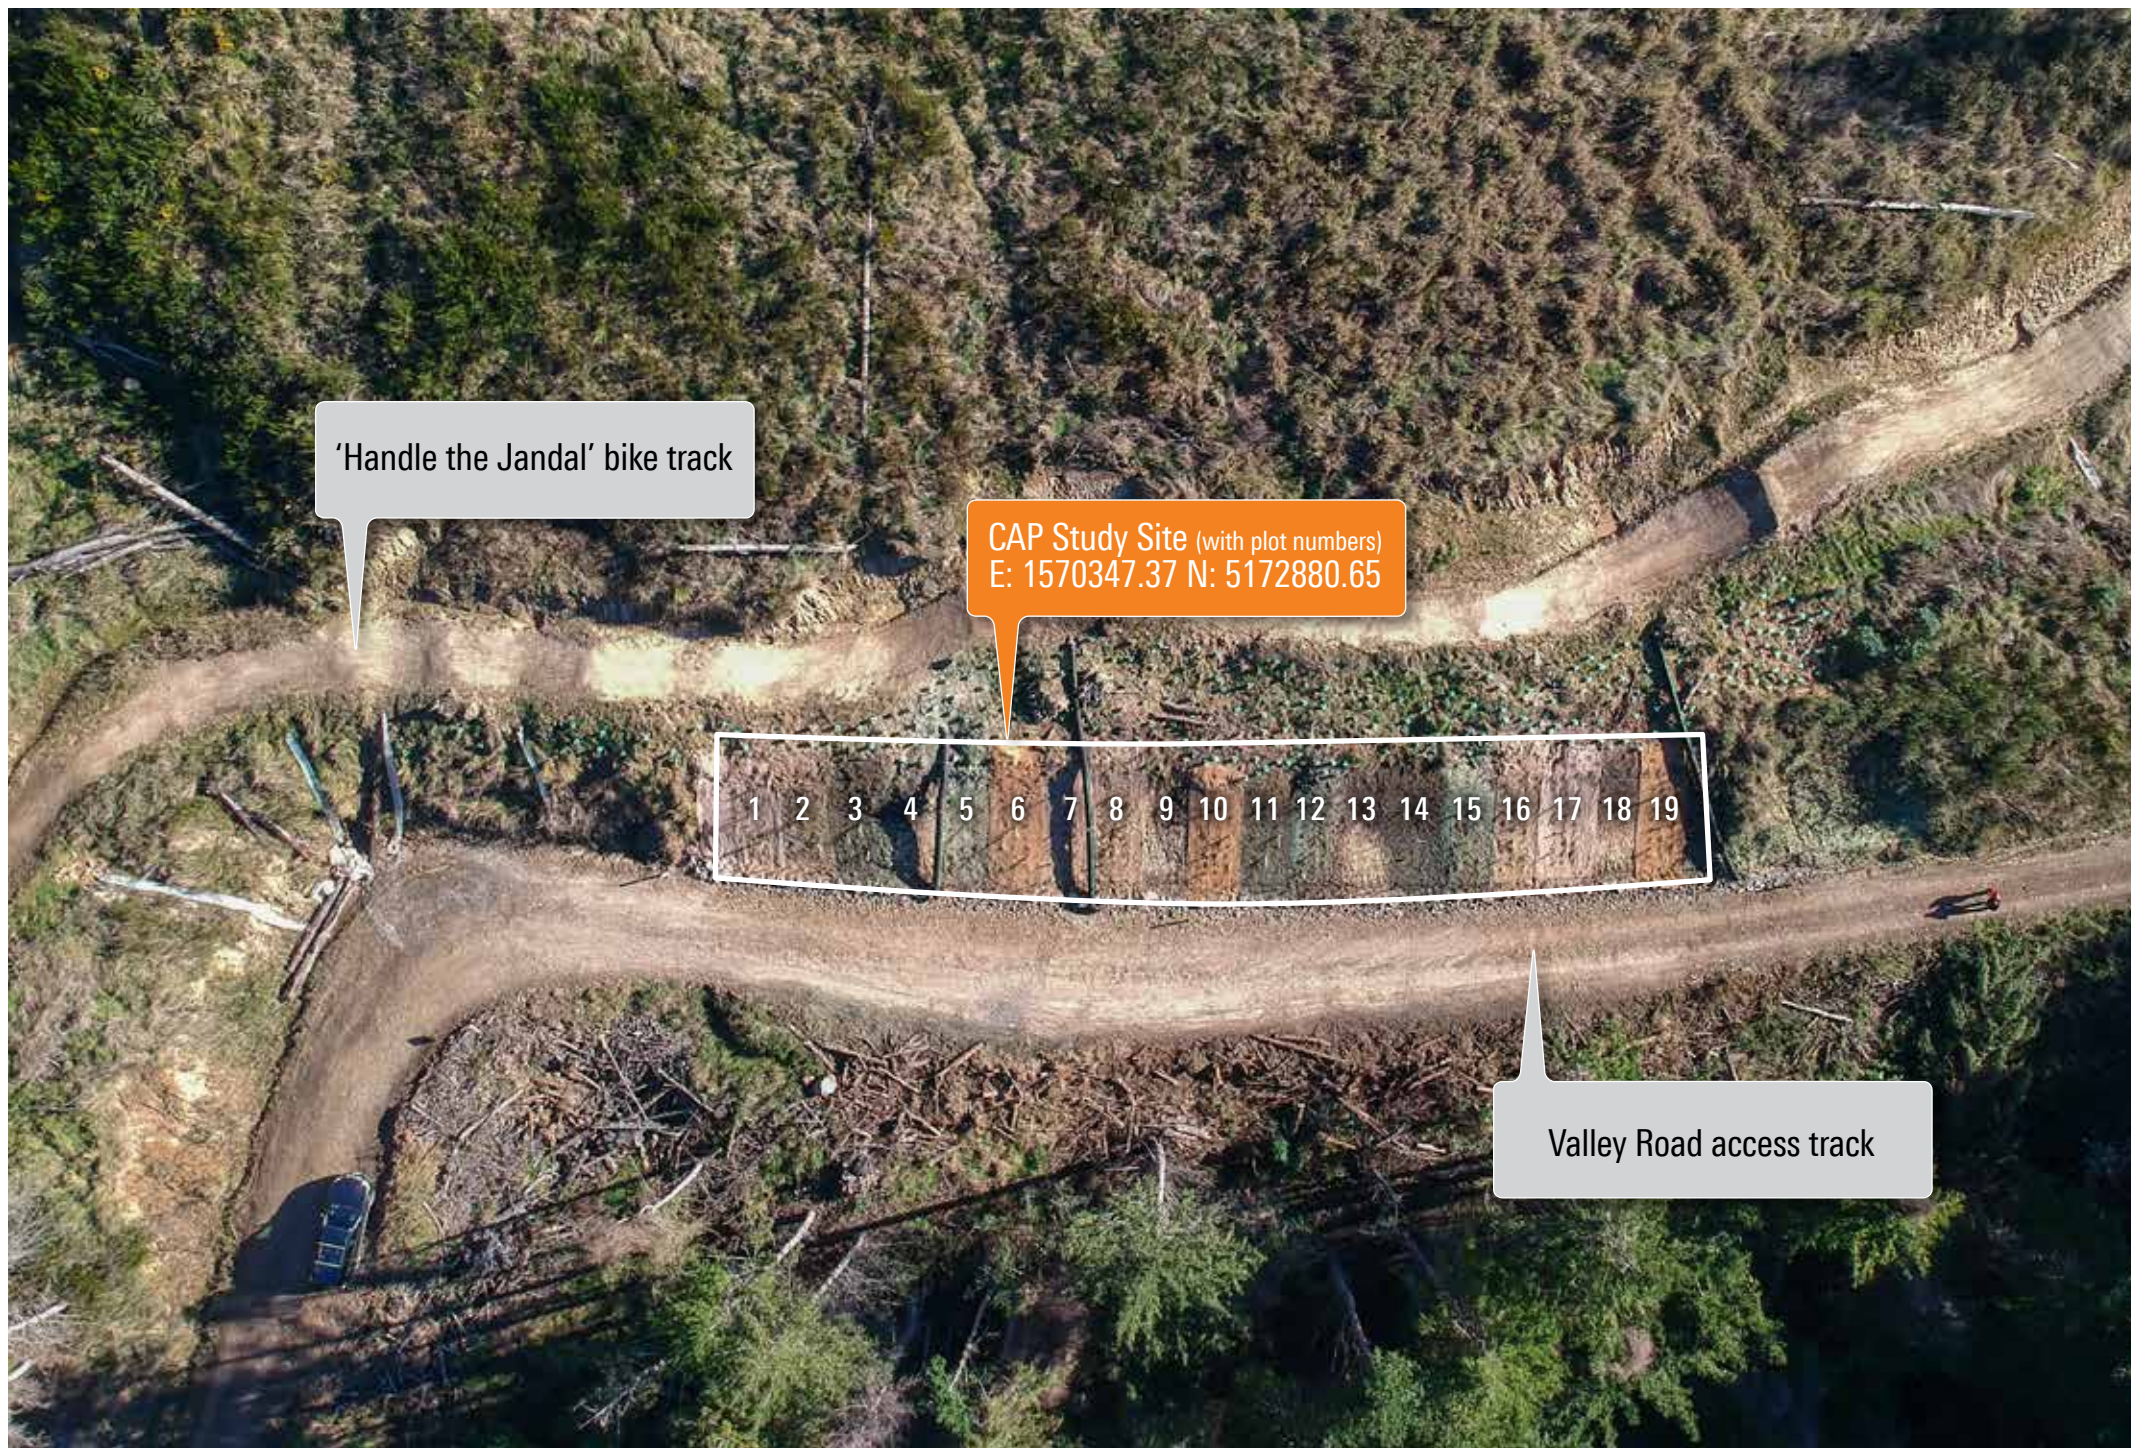
FIGURE 1: The location of the first cut slope soil erosion study site, located up Valley Road access track in the Christchurch Adventure Park. The individual test plots are numbered. Photo taken shortly after completion of the site setup, in June 2019.

The study has currently been implemented at one of four study sites. Located in the Christchurch Adventure Park (CAP), this first study site is a good example of a south facing cut loess slope typical of Port Hills and Banks Peninsula roads (Figure 1).

CAP Study Site (with plot numbers)
E: 1570347.37 N: 5172880.65

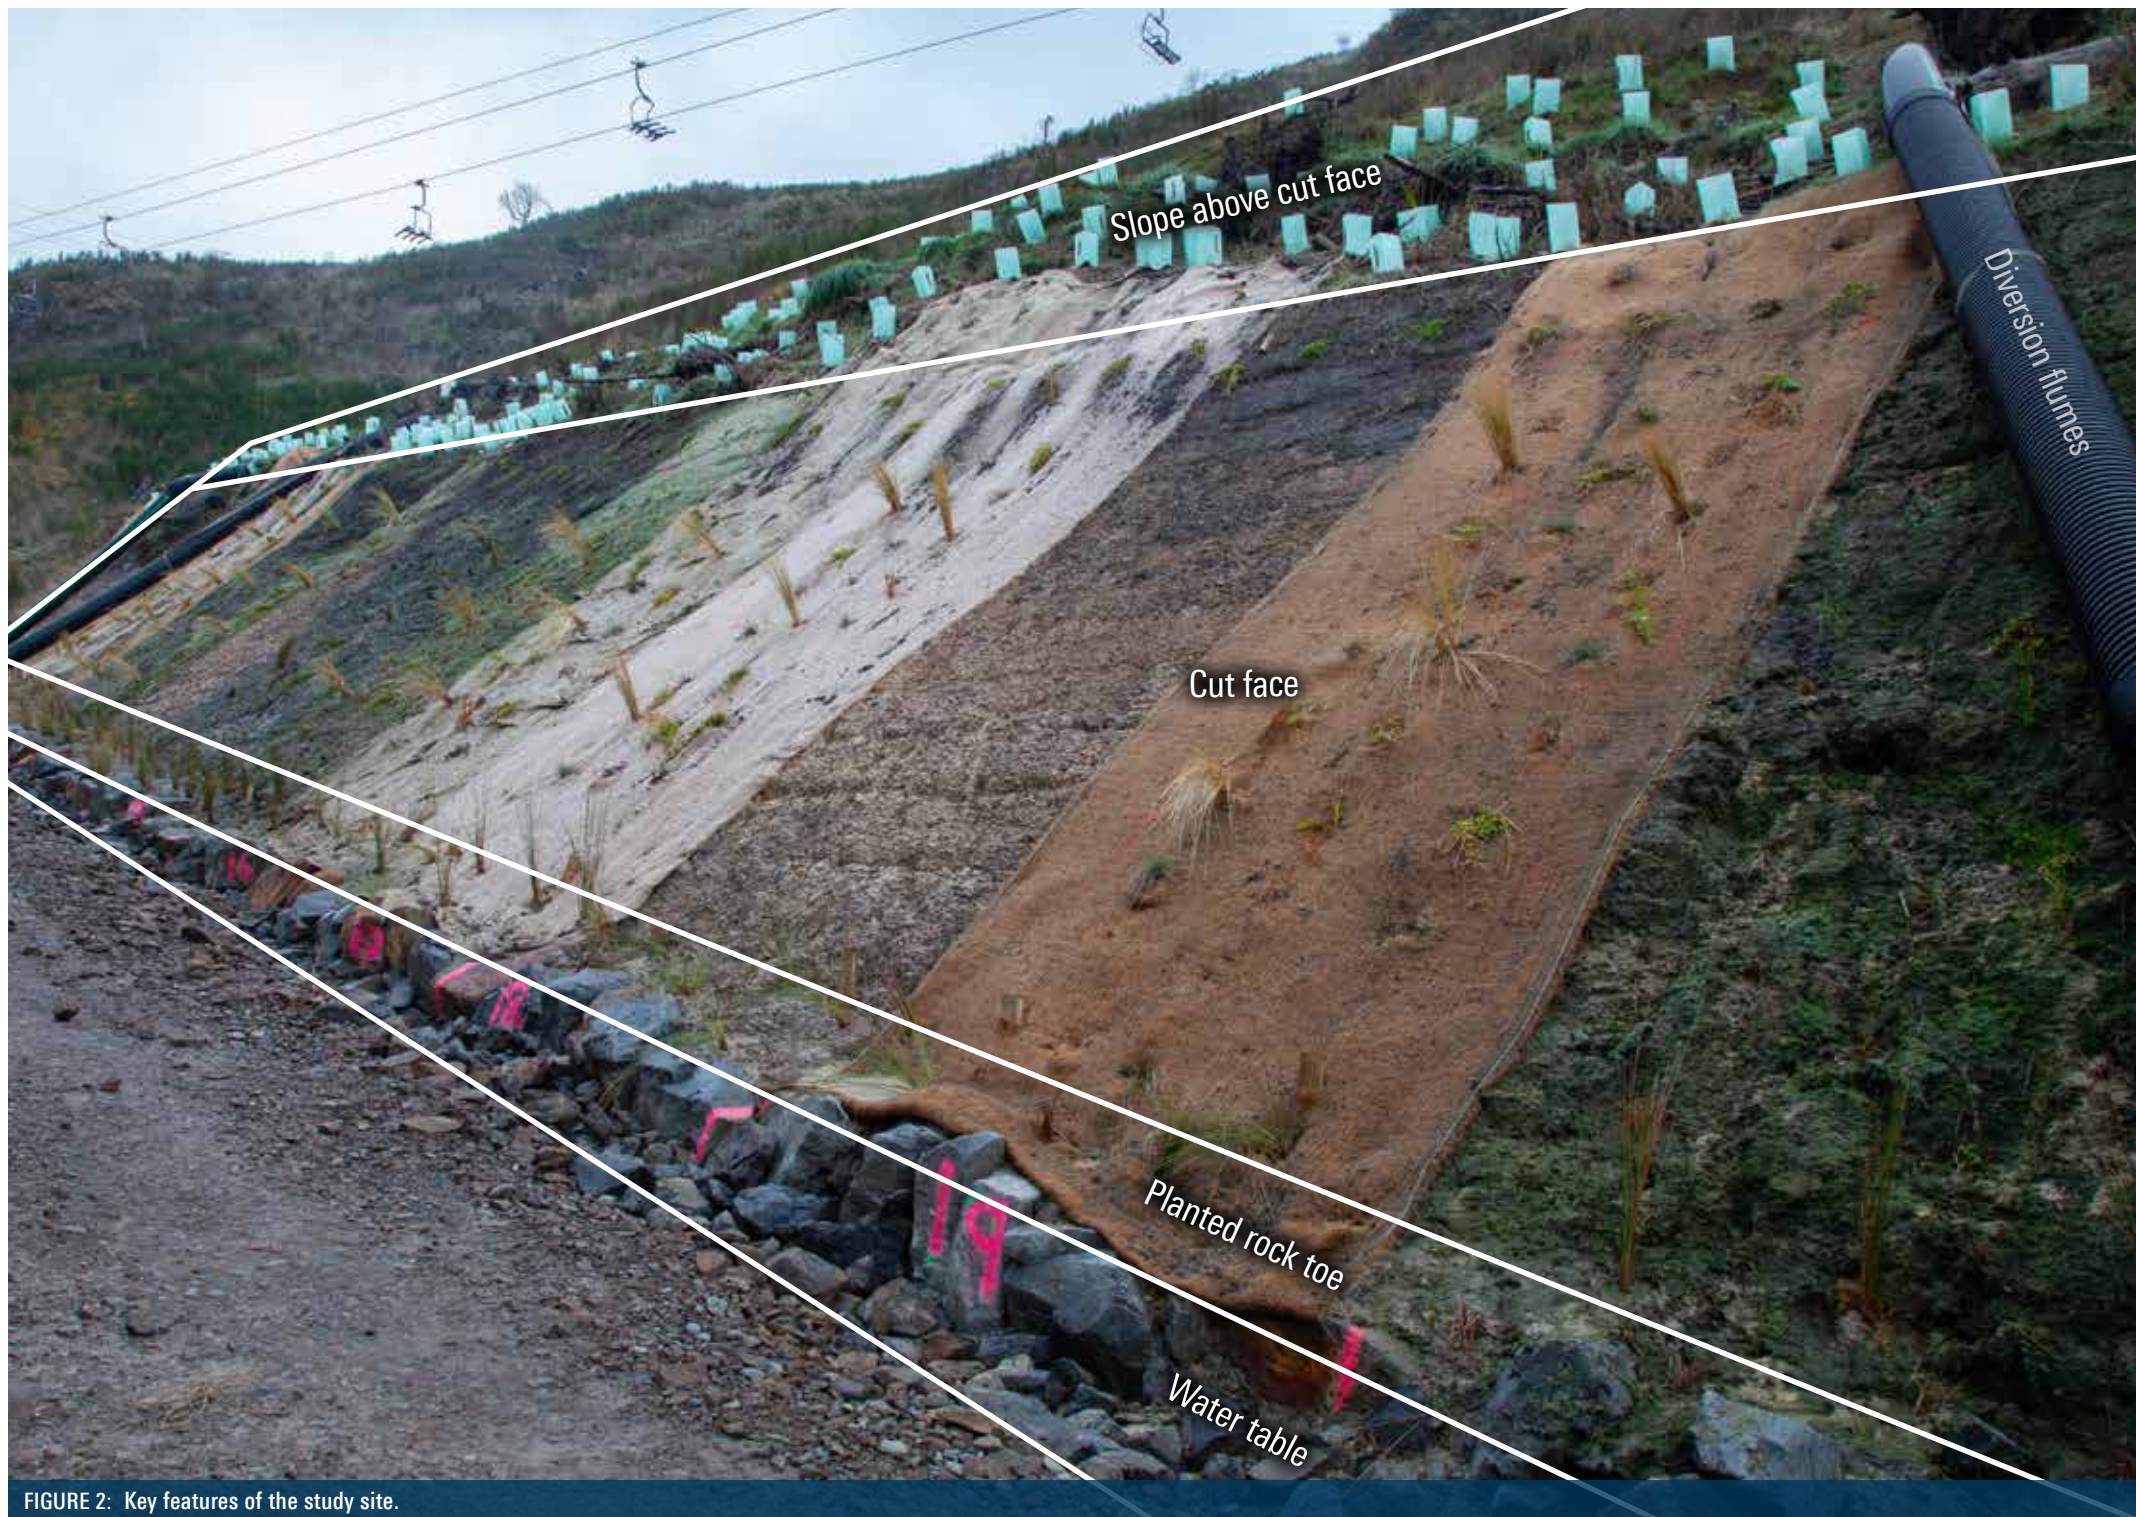
FIGURE 2: Key features of the study site.

Site-wide interventions (Figure 2):

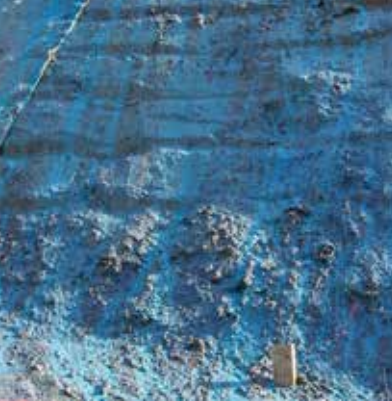
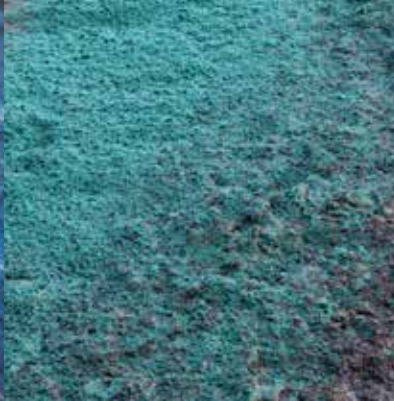
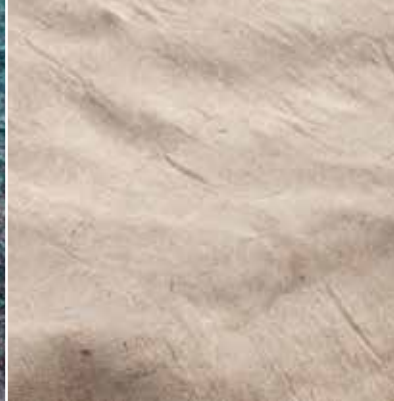
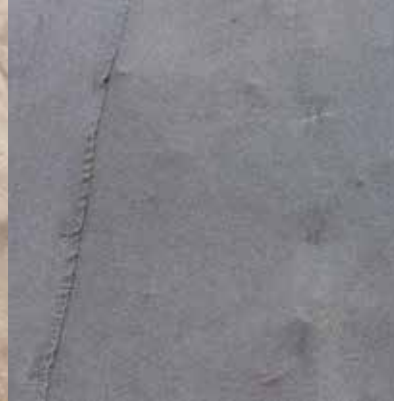
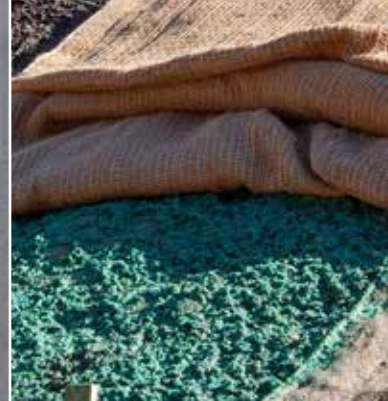
TABLE 1: Products applied to the cut face experimental plots.

SPRAYED		ROLLED		COMBO
Hydromulch + seed mix ('hydromulch mixed')	Hydromulch on organic base + seed mix ('hydromulch & base')	Coir fibre blanket ('rolled – jute')	Wool blanket ('rolled – wool')	Coir fibre blanket with Hydromulch + seed mix ('combo hydromulch & jute')

VE Gro-Matt & Vital polykelp mixed together	Flexterra HP-FGM with Proganics (top layer) Proganics BSM & Trichoflow Pro WP mixed together (base layer)	Geofabrics JuteMat 650	Terra Mulch	Geofabrics CJ450 + ProMatrix EFM
Wood fibres mixed with nutrient-infused stabilising biodegradable polymers and applied via spray.	Two organic bio stimulants applied first followed by a wood fibre mulch applied via spray.	A 'heavy weight' (650g/m ²) natural jute fibre blanket applied in rolls and secured with pins.	5 mm thick wool fibre blanket applied in rolls and secured with pins.	Promatrix Engineered Fibre Matrix (EFM) applied via spray, with coconut fibre blanket applied over top in rolls and secured with pins.

Applied with cover crop seed mixed in: Creeping red fescue, browntop, Poa, red clover.	Applied with cover crop seed mixed in: Creeping red fescue, browntop, Poa, red clover.	n/a	n/a	EFM applied with cover crop seed mixed in: Creeping red fescue, browntop, Poa, red clover.

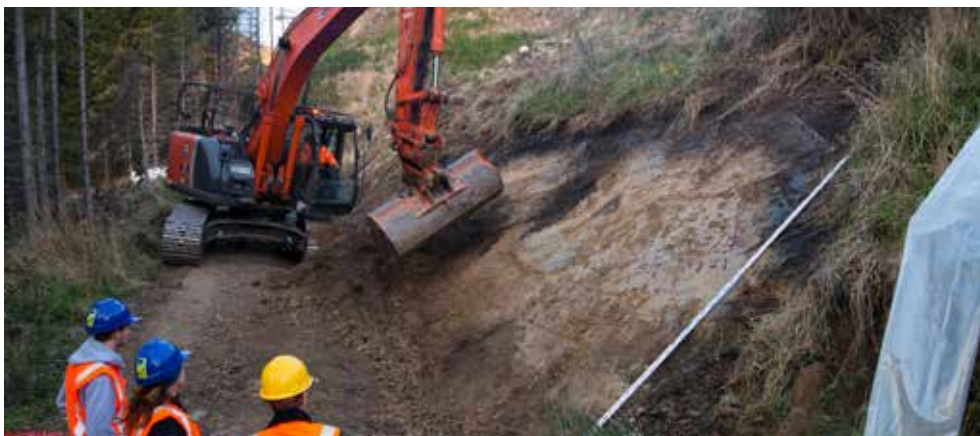
Fulton Hogan creating the cut face under the oversight of the science team.

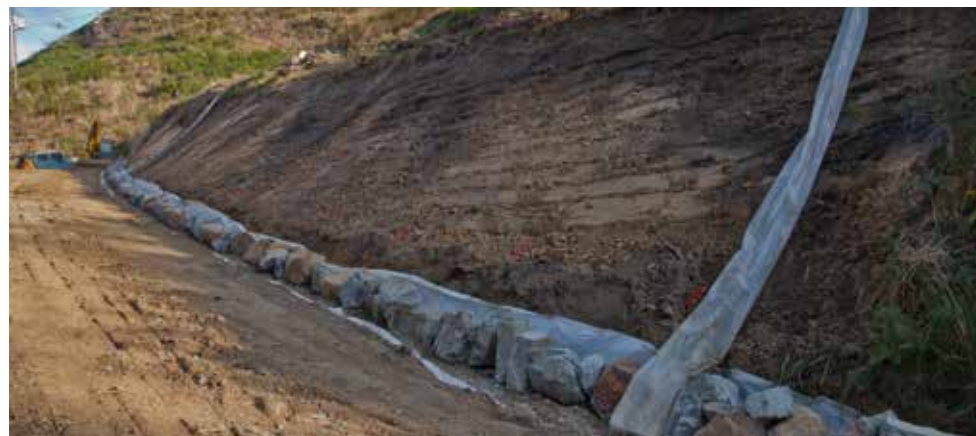
The cut face with horizontal 'scarifying' and the rock toe prior to backfilling. The plastic sheeting is a temporary flume prior to the installation of the diversion flumes.

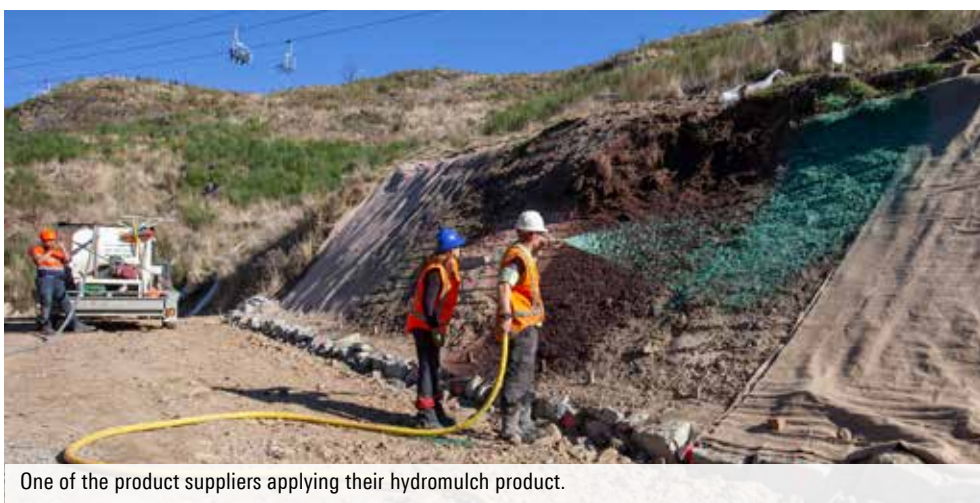
One of the product suppliers applying their hydromulch product.

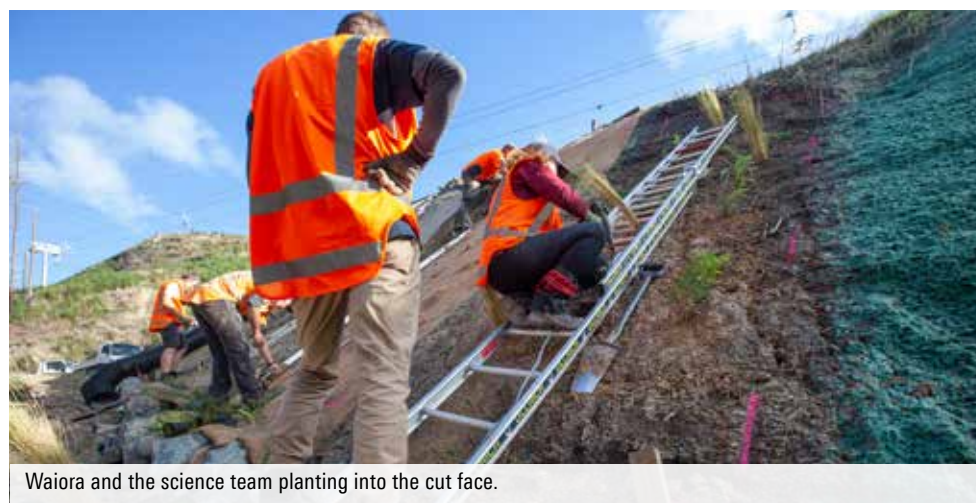
FIGURE 5: Site setup implemented in May–June 2019.

Waiora and the science team planting into the cut face.

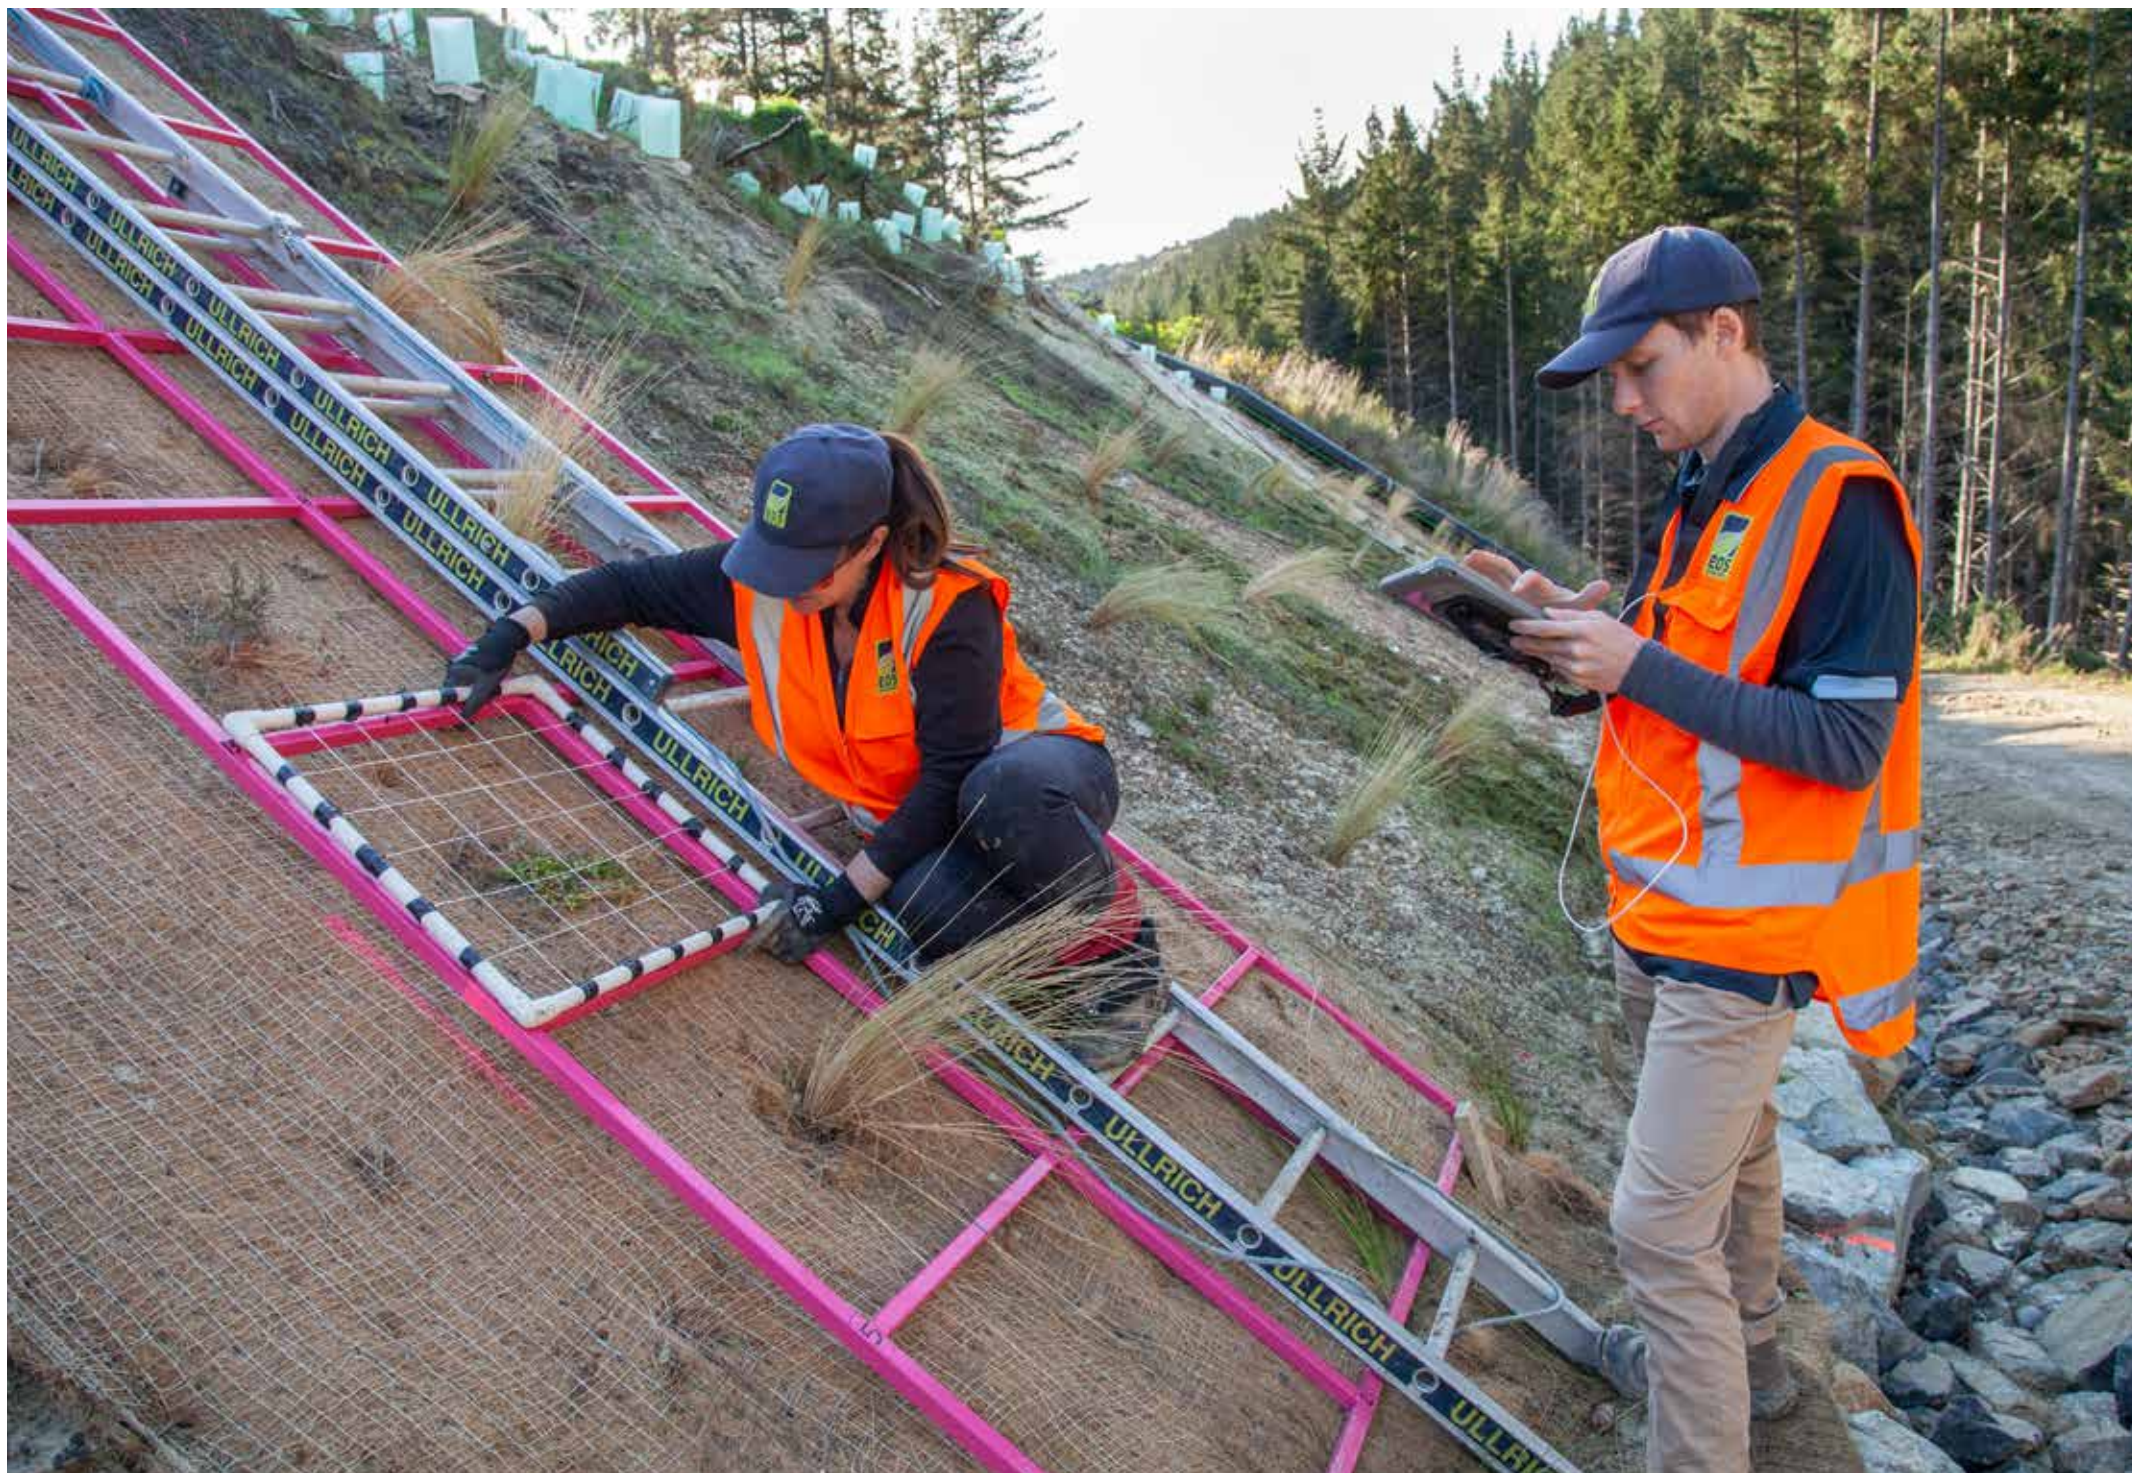
FIGURE 6: The science team using the monitoring grid and ladder to quantify conditions within 24 replicate grids for each plot in the cut face experiment.

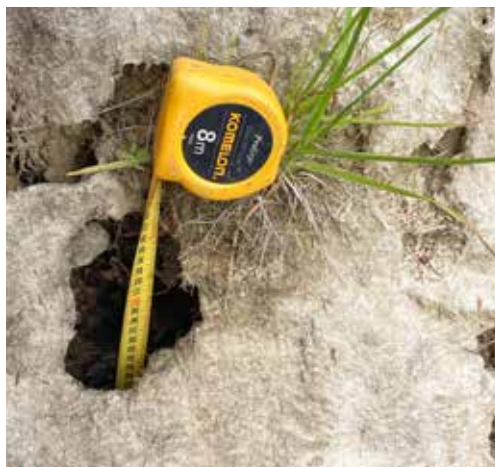
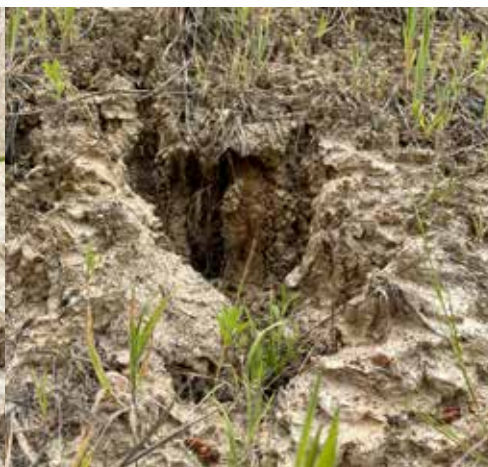
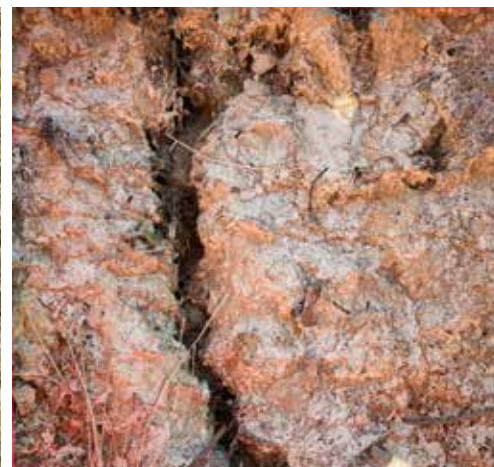
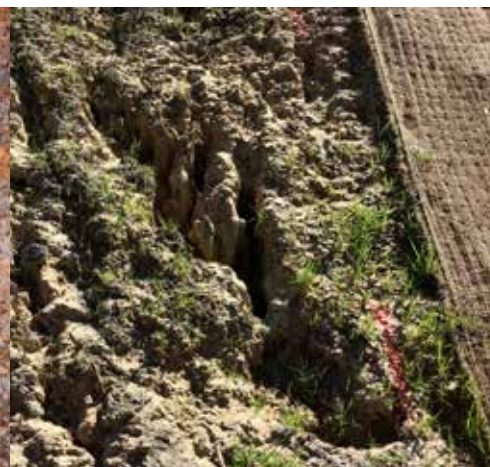
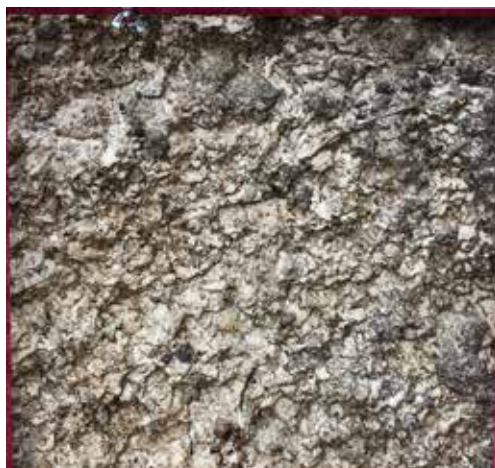
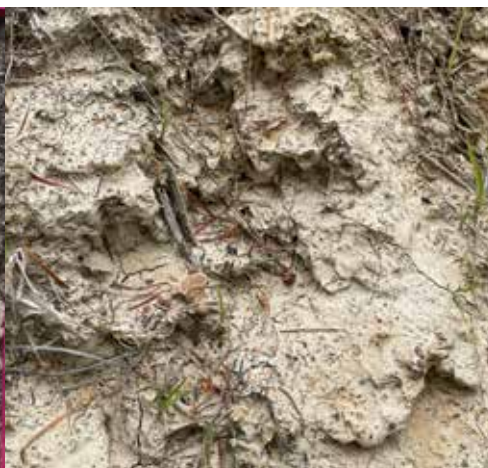
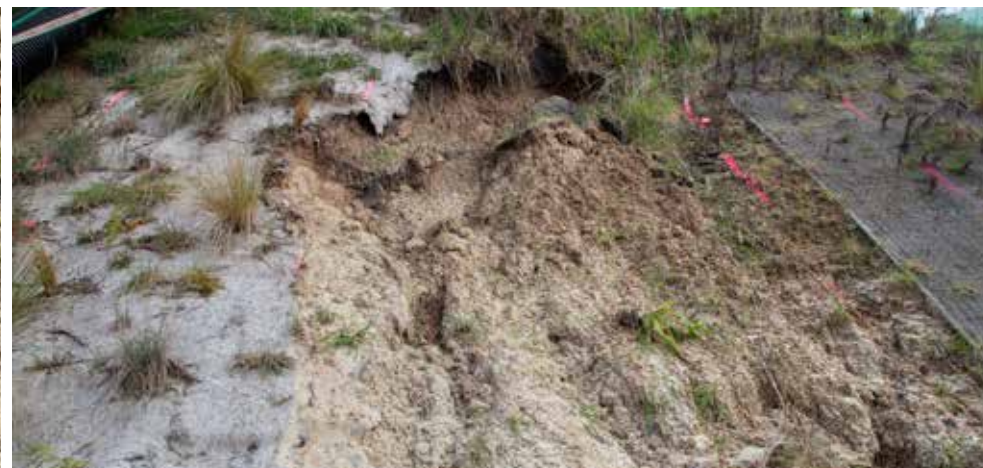
FIGURE 7: Different erosion features recorded during the Cut Slope Soil Erosion Control Trial at the Christchurch Adventure Park.

different erosion features (Figure 7). Undertaken five times: before the products were applied to the cut face (to classify underlying soil type), two rounds in Year 1 (2 and 11 months after site setup), and one round each in Year 2 (18 months) and Year 3 (30 months) (Table 2). Undertaken to classify the soil type in each grid of plot prior to application of any products or plants, and to determine if there was increasing stability/instability of the faces by comparing over time between treatment types and interpreted based on baseline conditions within each plot.

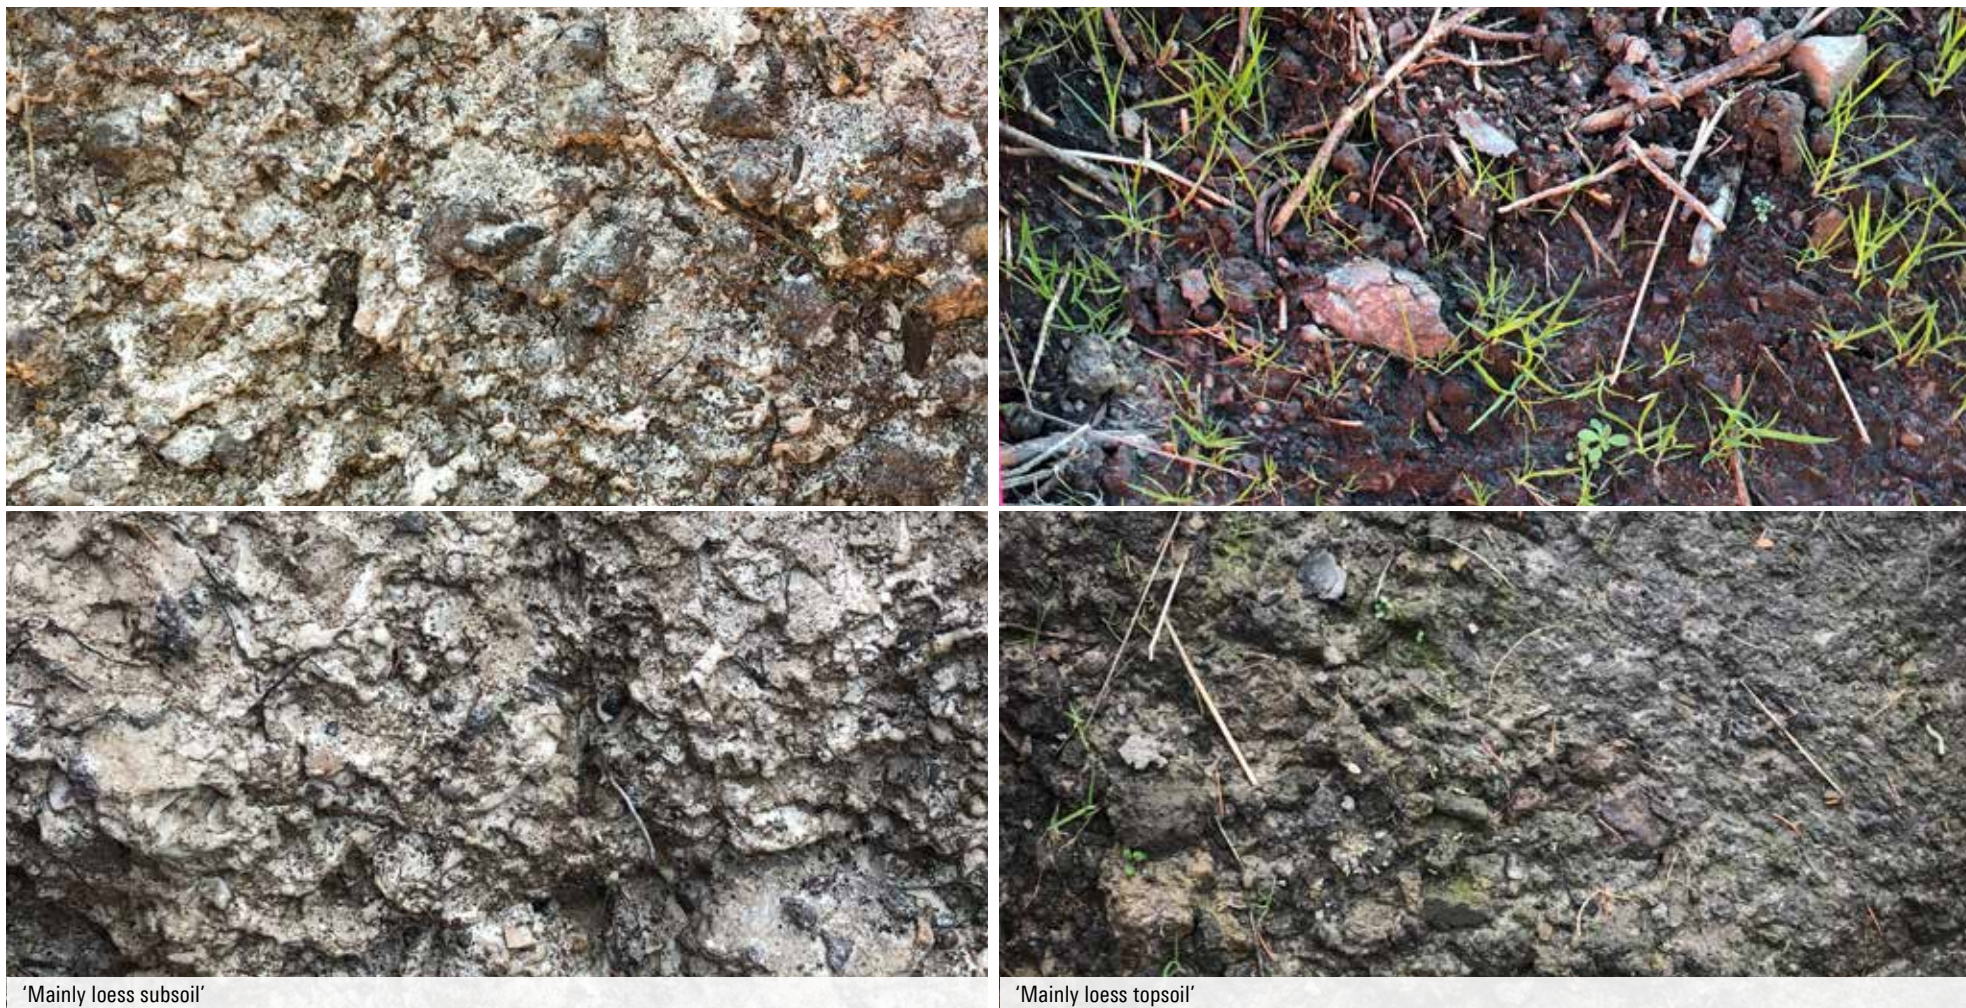
FIGURE 8: Photos showing grids dominated by loess topsoil vs loess subsoil

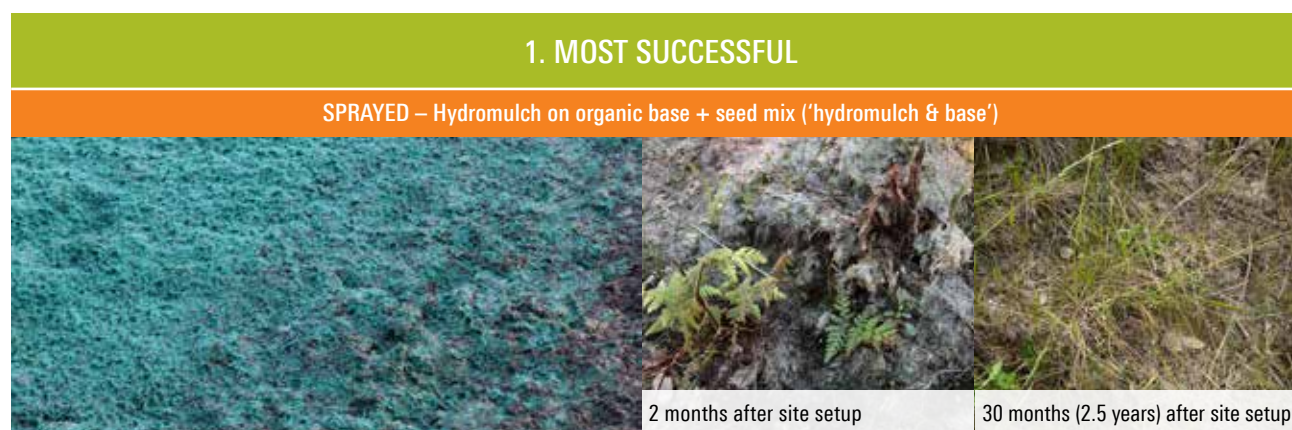
In terms of overall product-type performance for providing vegetation cover and limiting erosion features, the study rated the treatments in the following order of performance (Table 4):

The sprayed 'hydromulch & base' treatment performed the best, achieving the highest vegetation cover and lowest erosion cover categories of all the treatment types (Table 4).

- » By the final monitoring round 91% of 'mainly loess subsoil' grids supported >50% total vegetation cover (67% of grids with 75–100% vegetation cover and 24% with 50–75% cover) (Figure 9).

- » The only treatment to support (and retain) >50% vegetation cover in more than a quarter of 'mainly loess subsoil' grids by the second monitoring round (5 months after site setup) (Figure 9).

Products that provide a thick cover of the cut slope (i.e., the ‘hydromulch & base’ and ‘wool’ treatments) appear to provide the best erosion control as they help to retain moisture for plant growth, as well as prevent erosion by rainsplash or runoff.

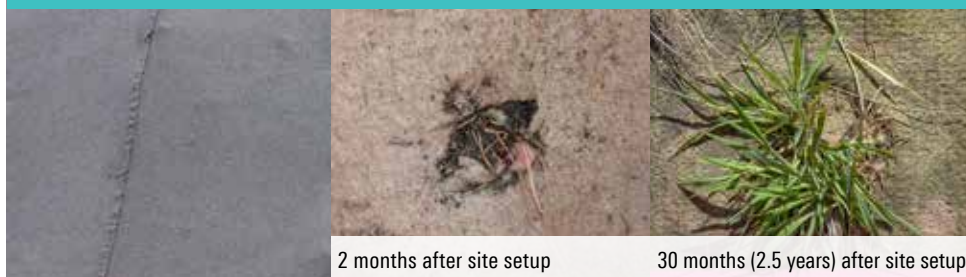
ROLLED – Wool blanket ('rolled – wool')

The rolled 'wool' treatment performed second-best overall, scoring second on the two vegetation-cover attributes, but retaining a first equal score for all the erosion attributes (Table 4).

- » By the final monitoring round 71% of 'mainly loess subsoil' grids supported >75% total vegetation cover (26% of grids with 75–100% vegetation cover and 24% with 50–75% cover) (Figure 9).

- » Only achieved >50% vegetation cover in more than a quarter of 'mainly loess subsoil' grids by the final monitoring round (30 months after site setup) (Figure 9).

- » Product cover retained throughout the 30 month monitoring period (97% of 'mainly loess subsoil' grids with 75–100% product cover at the final monitoring round). However, signs that the wool fibers in the rolled product were starting to degrade.

- However, whilst the rolled ‘wool’ treatment had not yet started to break down, when this eventually occurs the underlying soil will be exposed to rainfall and erosion without the added plant seed available for subsequent germination, as in the hydromulch treatments. As the wool treatment was effective in controlling the growth of adventive species, when the product degrades it is likely that, excluding the plug plants that have been able to establish, any remaining areas of bare soil will become sources for erosion. Alternatively, if the wool continues degrading slowly, plant colonisation will keep pace. Thus, it will be important to continue this monitoring to plot the changes that occur with the degradation of the rolled product.

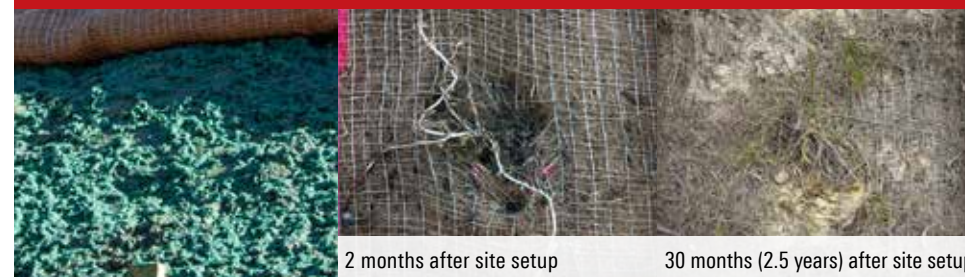
COMBO – Coir fibre blanket with Hydromulch + seed mix ('combo hydromulch & jute')

The combination 'combo hydromulch & jute' treatment scored third overall, with a first equal score for all the erosion attributes but coming third and last equal for the two vegetation cover attributes.

- » By the final monitoring round 34% of 'mainly loess subsoil' grids supported >50% total vegetation cover (5% of grids with 75–100% vegetation cover and 29% with 50–75% cover) (Figure 9).

- » Only achieved >50% vegetation cover in more than a quarter of 'mainly loess subsoil' grids by the final monitoring round (30 months after site setup) (Figure 9).

- » Product cover mostly retained throughout the 30 month monitoring period (93% of 'mainly loess subsoil' grids with 75–100% product cover at the final monitoring round). Although evidence of degradation of the rolled jute product, the underlying hydromulch retained integrity throughout the monitoring period.

- » The rolled product prevented the effective germination of the grass seed in the underlying hydromulch.
- » As the rolled product started to degrade the underlying hydromulch remained evident and continued to protect the face from erosion. Thus, it is possible that as the rolled product degrades further the underlying hydromulch may continue to provide erosion protection and a growing substrate for the contained seed (should it still be viable) and adventive vegetation.
- » However, given that the cost of applying both a hydromulch and rolled product is effectively double that of the individual treatments, and the combination performs worse than the individual treatments, it is unlikely to be a viable option.

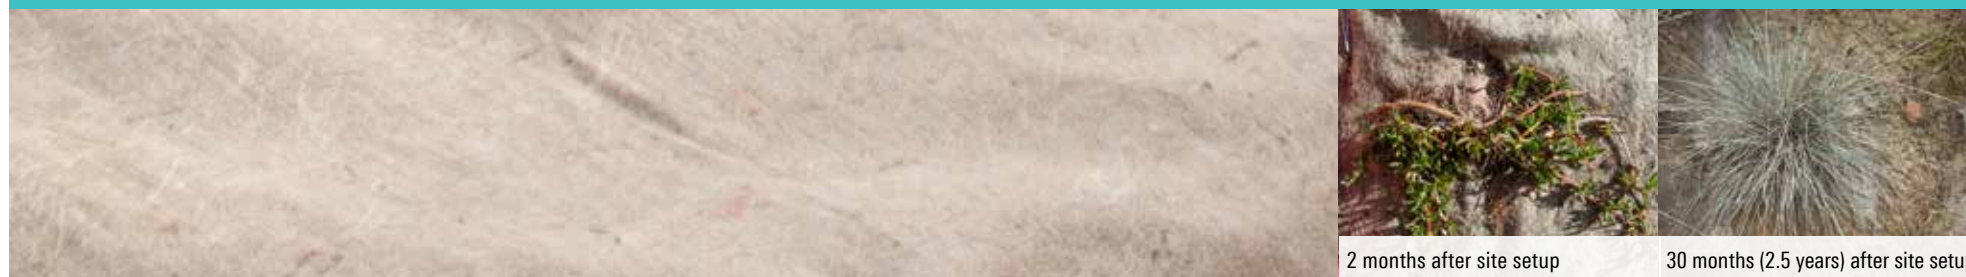
ROLLED – Coir fibre blanket ('rolled – jute')

The 'jute' treatment performed similarly to the control (i.e., plots with no treatments or plug plants applied) in relation to the vegetation cover attributes, but performed better than the control in relation to reducing erosion features - where it scored second on all five erosion attributes.

- » By the final monitoring round 19% of 'mainly loess subsoil' grids supported >50% total vegetation cover (7% of grids with 75–100% vegetation cover and 12% with 50–75% cover). This was little different to the control plots which had 21% of 'mainly loess subsoil' grids with >50% total vegetation cover (Figure 9).

- » Did not achieve >50% vegetation cover in more than a quarter of 'mainly loess subsoil' grids at any time in the study (Figure 9).
- » Product cover diminished by the final monitoring round (30 months after site setup) (only 64% of 'mainly loess subsoil' grids with 75–100% product cover). Some product degradation began in the fifth monitoring round, 18 months after site setup.

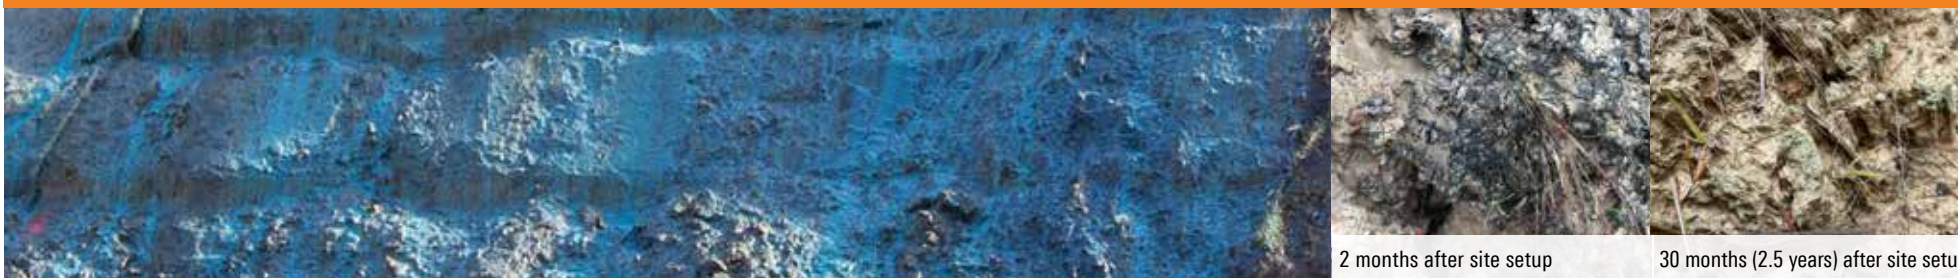
SPRAYED – Hydromulch + seed mix ('hydromulch mixed')

The sprayed 'hydromulch mixed' treatment scored lowest equal with the control for all vegetation and erosion cover attributes; and as such was little different to the control plots that had no treatments or plug plants applied.

- » By the final monitoring round 18% of 'mainly loess subsoil' grids supported >50% total vegetation cover (8% of grids with 75–100% vegetation cover and 10% with 50–75% cover). This was little different to the control plots which had 21% of 'mainly loess subsoil' grids with >50% total vegetation cover. (Figure 9).
- » Did not achieve >50% vegetation cover in more than a quarter of 'mainly loess subsoil' grids at any time in the study (Figure 9).
- » Product cover greatly diminished by the final monitoring round (30 months after site setup) (only 21% of 'mainly loess subsoil' grids with 75–100% product cover). Product

degradation increased from the fifth monitoring round (18 months after site setup), with most degradation occurring at the final monitoring round (30 months after site setup).

- » The thinner nature of the sprayed ‘hydromulch mixed’ treatment meant that whilst the cut face was initially covered with hydromulch there was not a substantial thickness to provide beneficial growing conditions for vegetation and to continue to provide cover of the cut face. Whilst the product remained on the cut face it did provide some erosion protection, but it soon became eroded from the surface, with the proportion of erosion features similar to the control plots by the end of the monitoring period. Thus, whilst at the end of the monitoring period there were small pockets where the product remained, evidence of erosion was evident around them. The product also did not appear to provide beneficial growing conditions for the grass seed in the hydromulch, with vegetation cover being comparable to that of the control plots.
