Cut Slope Soil Erosion Control Trial

CAP Site 1: REPORT SUMMARY

EOS Ecology Report No. CHR01-20077-03 | November 2022

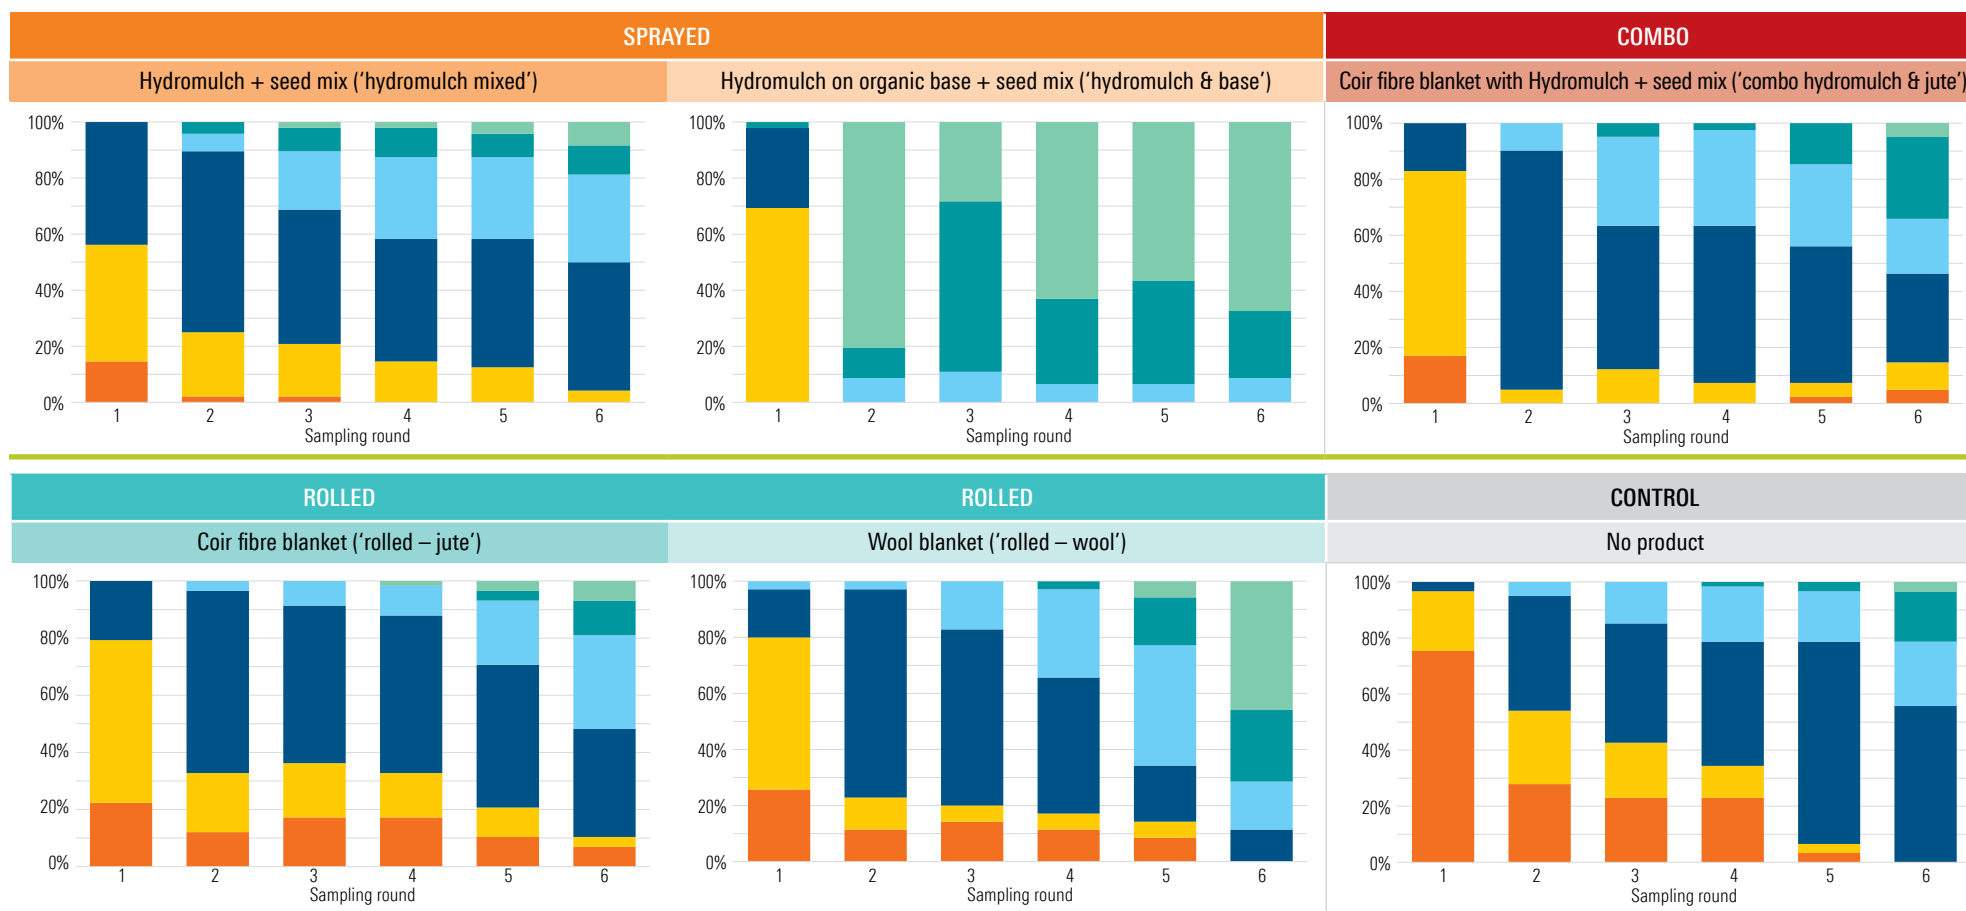
FIGURE 9: Stacked bar graphs showing the PERCENTAGE COVER OF ALL VEGETATION IN GRIDS across five different treatments and control ('no product'), for grids that were classified as 'mainly loess subsoil'. Data is based on the proportion of grids that were classified as one of six cover categories, and is presented for each monitoring round, undertaken approximately 2, 5, 8, 11, 18 (1.5 years) and 30 months (2.5 years) after site setup.

- » By the final monitoring round 91% of 'mainly loess subsoil' grids supported >50% total vegetation cover (67% of grids with 75–100% vegetation cover and 24% with 50–75% cover) (Figure 9).

- » By the final monitoring round 71% of 'mainly loess subsoil' grids supported >75% total vegetation cover (26% of grids with 75–100% vegetation cover and 24% with 50–75% cover) (Figure 9).

- » By the final monitoring round 34% of 'mainly loess subsoil' grids supported >50% total vegetation cover (5% of grids with 75–100% vegetation cover and 29% with 50–75% cover) (Figure 9).

- » By the final monitoring round 19% of 'mainly loess subsoil' grids supported >50% total vegetation cover (7% of grids with 75–100% vegetation cover and 12% with 50–75% cover). This was little different to the control plots which had 21% of 'mainly loess subsoil' grids with >50% total vegetation cover (Figure 9).

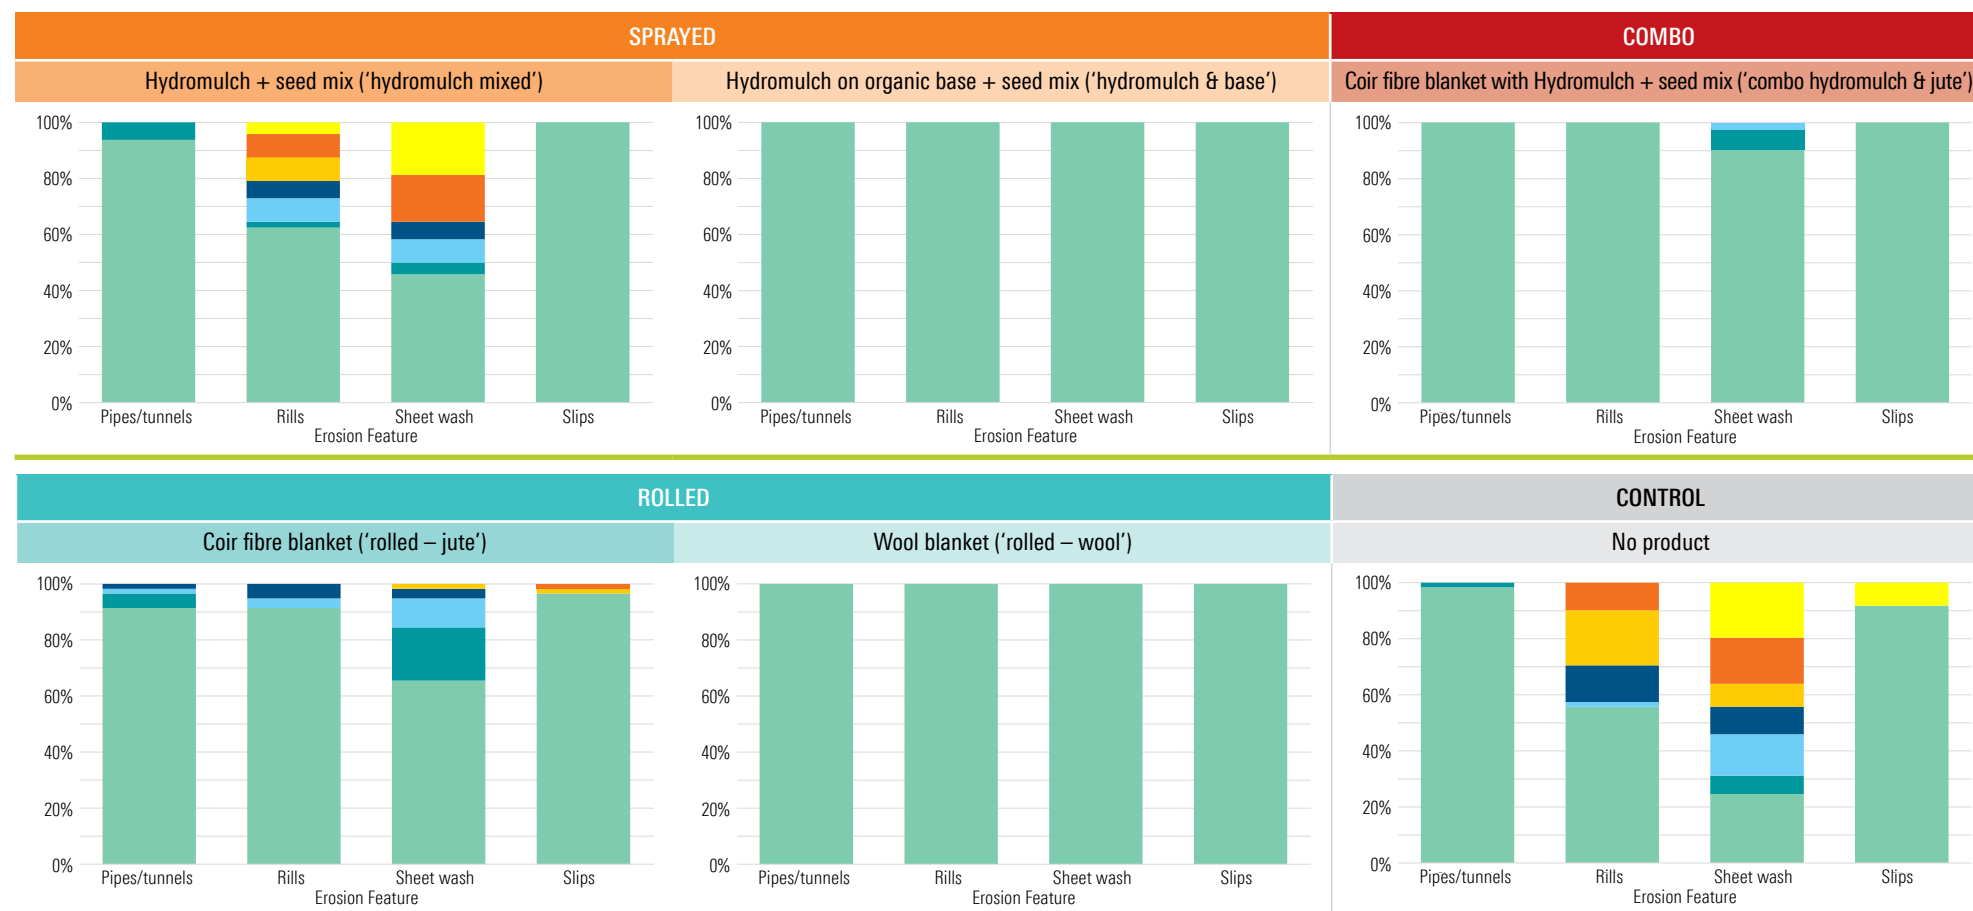
FIGURE 10: Graph showing the PROPORTION OF THE DIFFERENT TYPES OF EROSION FEATURES in grids across the five different treatments and control ('no product'), for grids that were classified as 'mainly loess subsoil'. Data for the % cover categories is based on the proportion of grids that were classified as one of six cover categories. Data is presented for the last round of monitoring only, undertaken approximately 30 months (2.5 years) after site setup.

Products that provide a thick cover of the cut slope (i.e., the ‘hydromulch & base’ and ‘wool’ treatments) appear to provide the best erosion control as they help to retain moisture for plant growth, as well as prevent erosion by rainsplash or runoff.

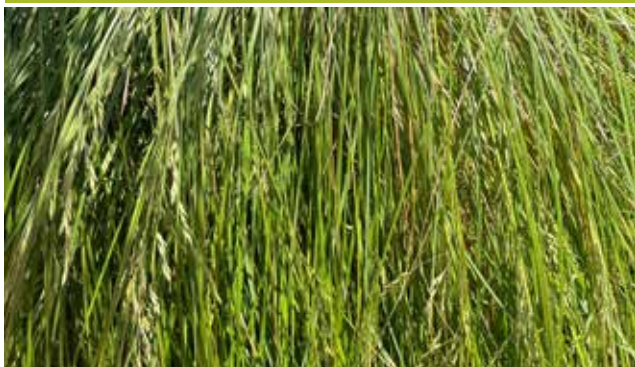
1. MOST SUCCESSFUL Silver tussock (*Poa cita*)

The plug plant that appeared the most successful in the loess-dominated cut face over the 2.5-year monitoring period was the native grass silver tussock (*Poa cita*).

- » This large grass performed the best on all cover and vigour attributes. Despite this the results were variable with only 30% of the 'mainly loess subsoil' grids achieving >50% cover by the end of the 2.5-year monitoring period.
- » We would recommend this as a plug plant to use in helping to stabilise loess cut slopes but would need to be planted more densely than what was done in this study to provide more continuous cover, or alternatively consider turf grasses as an inter-tussock sward.

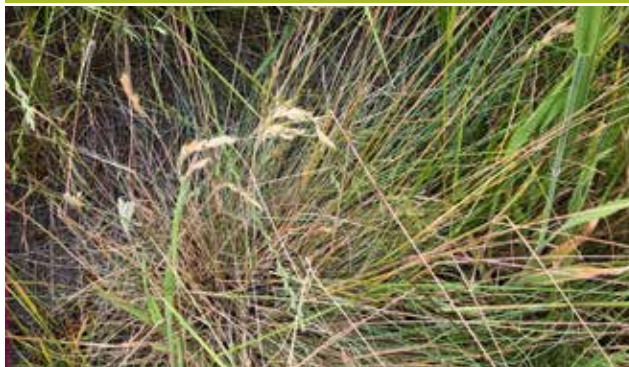
2. SECOND-MOST SUCCESSFUL Banks Peninsula fescue (*Festuca actae*)

Banks Peninsula fescue was the only other plug plant that performed reasonably well, second only to silver tussock.

- » However, this grass is a smaller stature species and as such only 5% of 'mainly loess subsoil' grids achieved >50% cover by the end of the 2.5 year monitoring period.
- » If this plant is to be used in loess cut faces it would need to be planted more closely than larger stature plants such as *Poa cita*, and/or consider the combined application of turf grasses as an inter-tussock sward.

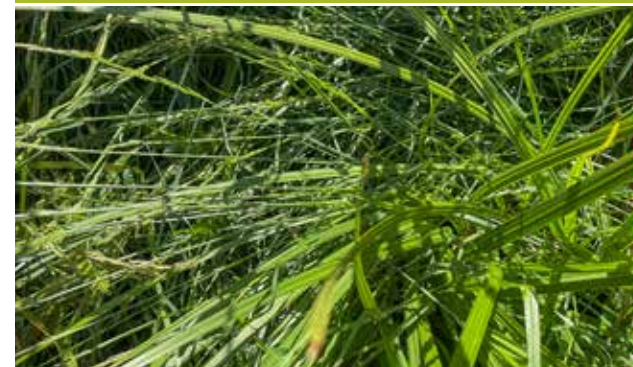
3. LESS SUCCESSFUL Cutty grass (*Carex geminata*)

The cutty grass (*Carex geminata*) sedge had variable performance, with some specimens of cutty grass surviving and spreading but cover still only reaching 25–50% cover category in 3% of 'mainly loess subsoil' grids.

- » Whilst this cutty grass is not a successful plant for providing coverage of a cut loess face on its own, it may be worthy of including in a species mix to plant; if it survives it will be able to spread via rhizomes over time. It would likely benefit from being planted in the late spring/early summer in wetter sites (toe slopes) so that photosynthetic activity is winding up and thus the plant is better able to feed root growth, thereby enabling establishment.

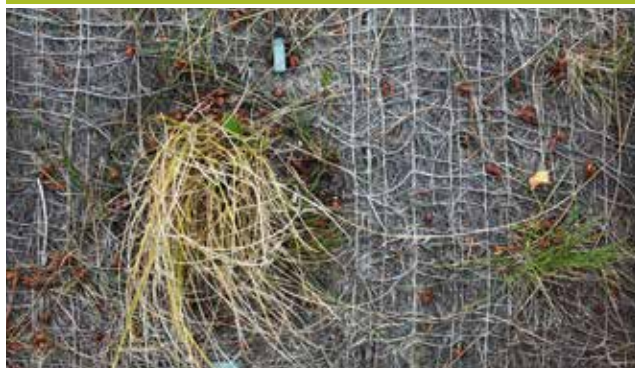
4. UNSUCCESSFUL Sedge (*Carex comans*)

The sedge *Carex comans* had the same level of coverage at the end of the monitoring period as the cutty grass, but the plants were less vigorous, and it is uncertain if they will continue to survive in the long-term.

- » As this species had only been planted 12 months into the programme it has not had as long to establish on the face, but its current development indicates that it may not be successful in the long-term. There is, however, no good reason why it shouldn't perform well on dry slopes like this, other than establishment problems.
- » It needs to be clarified that failure in this trial doesn't necessarily mean the species should be abandoned, but rather better establishment techniques are required, or a longer monitoring period to plot ongoing establishment.

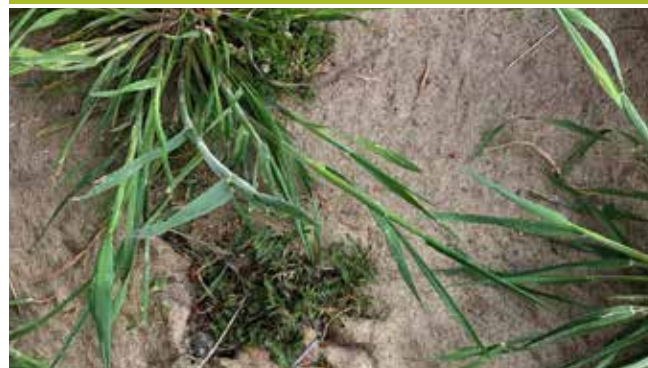
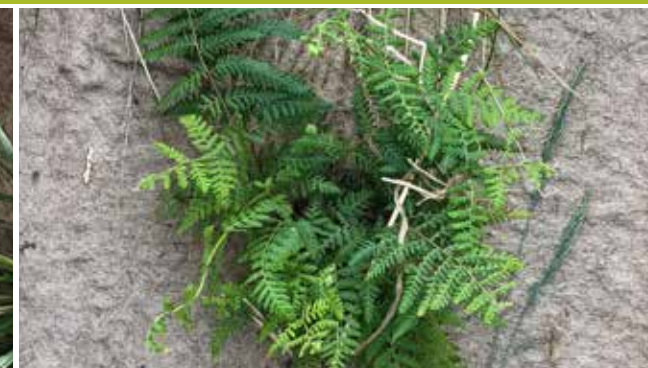
5. UNSUCCESSFUL Bracken fern (*Pteridium esculentum*) & Pig fern (*Hypolepis ambigua*)

The two ferns – bracken fern (*Pteridium esculentum*) and pig fern (*Hypolepis ambigua*) – were not successful in the 'mainly loess subsoil' grids.

- » Most were dead by the end of the monitoring period and what little cover remained was in the 5–25% cover category.
- » Both species die back in winter, and it is possible that the especially dry month following Round 3, combined with a natural winter dieback of live vegetation, may have negatively affected plant survival. However, even with all dead specimens being replaced after 12 months there was a similar level of mortality in the subsequent period.

- » It may be relevant to try an alternative approach to planting, which would be the inclusion of spores in any sprayed hydromulch product. Some initial trials using fern gametophytes in a hydroseeding mix showed that the viability of gametophytes of NZ native ferns (specifically *Blechnum novae-zelandiae*, *Cyathea medullaris* and *Dicksonia squarrosa*) was retained during the macerating process of hydroseeding (Denton-Giles, 2006). However, large scale in vitro propagation of fern gametophytes would be needed to first optimise survival prior to being used in commercial hydroseeding (Denton-Giles, 2006). This will be very species-dependent as well as being dependent on the rainfall and/or soil moisture environment.

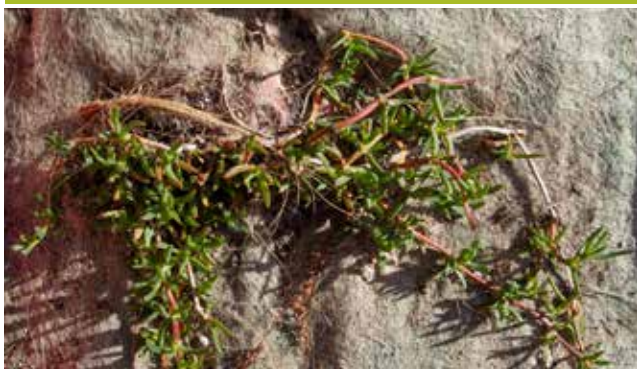
6. UNSUCCESSFUL NZ ice plant (*Disphyma australe*)

UNSUCCESSFUL, BUT LIKELY TO WORK IN THE ABSENCE OF GRAZING PESTS: The NZ ice plant (*Disphyma australe*) grew well in the initial months following planting but due to the persistent grazing by possums they were dead by the second monitoring round.

- » Due to the unusually high numbers of possums in the CAP area and a lack of a concerted possum control programme in the park it was deemed unviable to replace the dead plants with new specimens. However, in areas where the possum population is under better control there is the potential for this plant to provide good coverage of a loess cut slope.
- » To provide a more definitive answer however would require inclusion of this plant in another cut slope erosion control trial location.

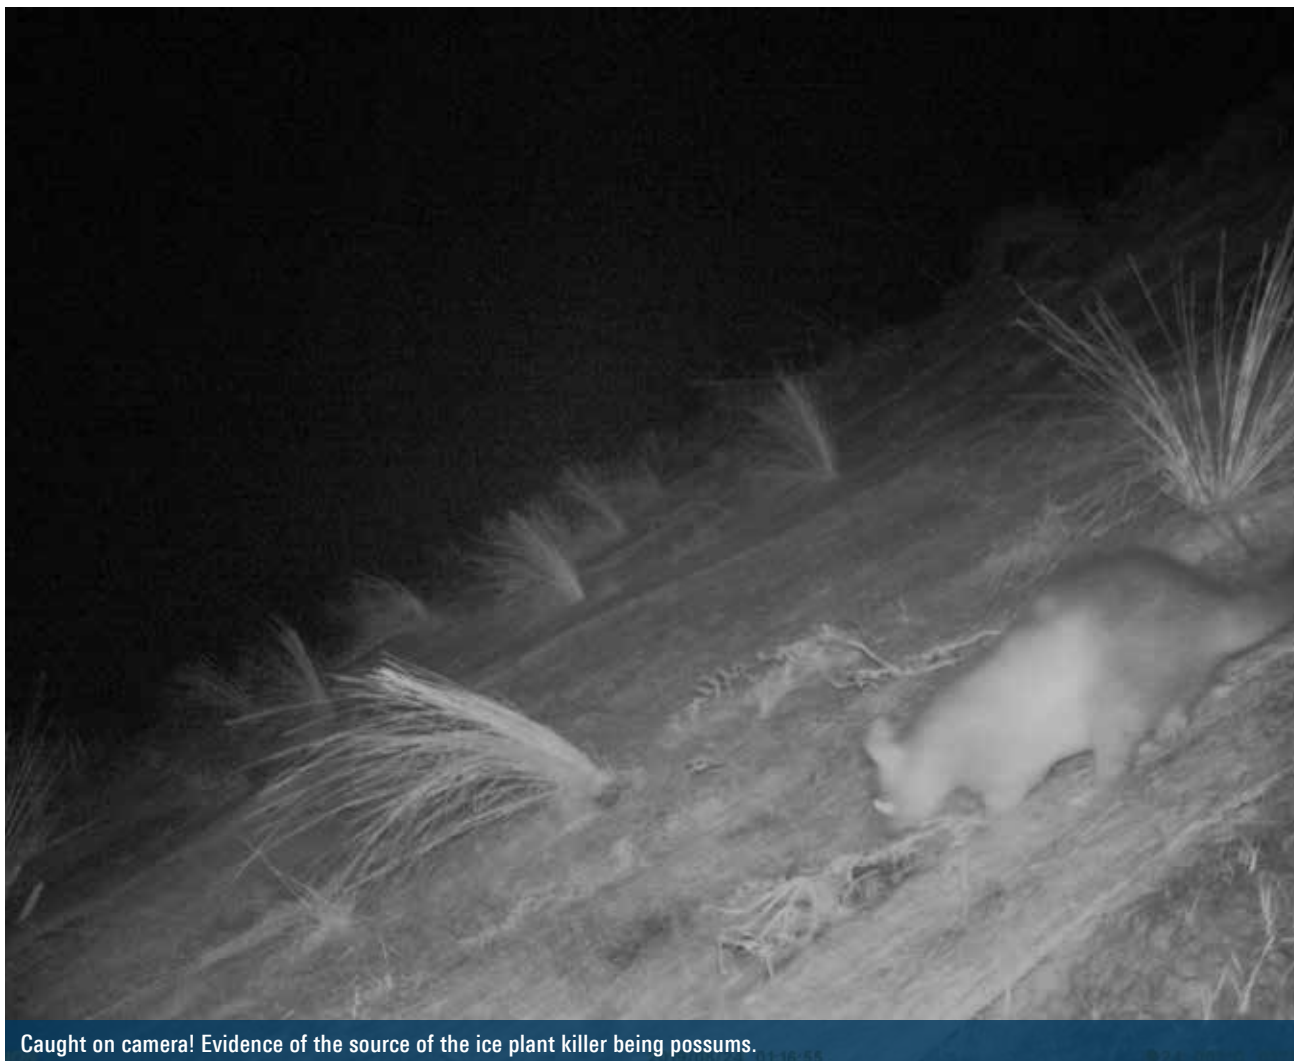
Caught on camera! Evidence of the source of the ice plant killer being possums.

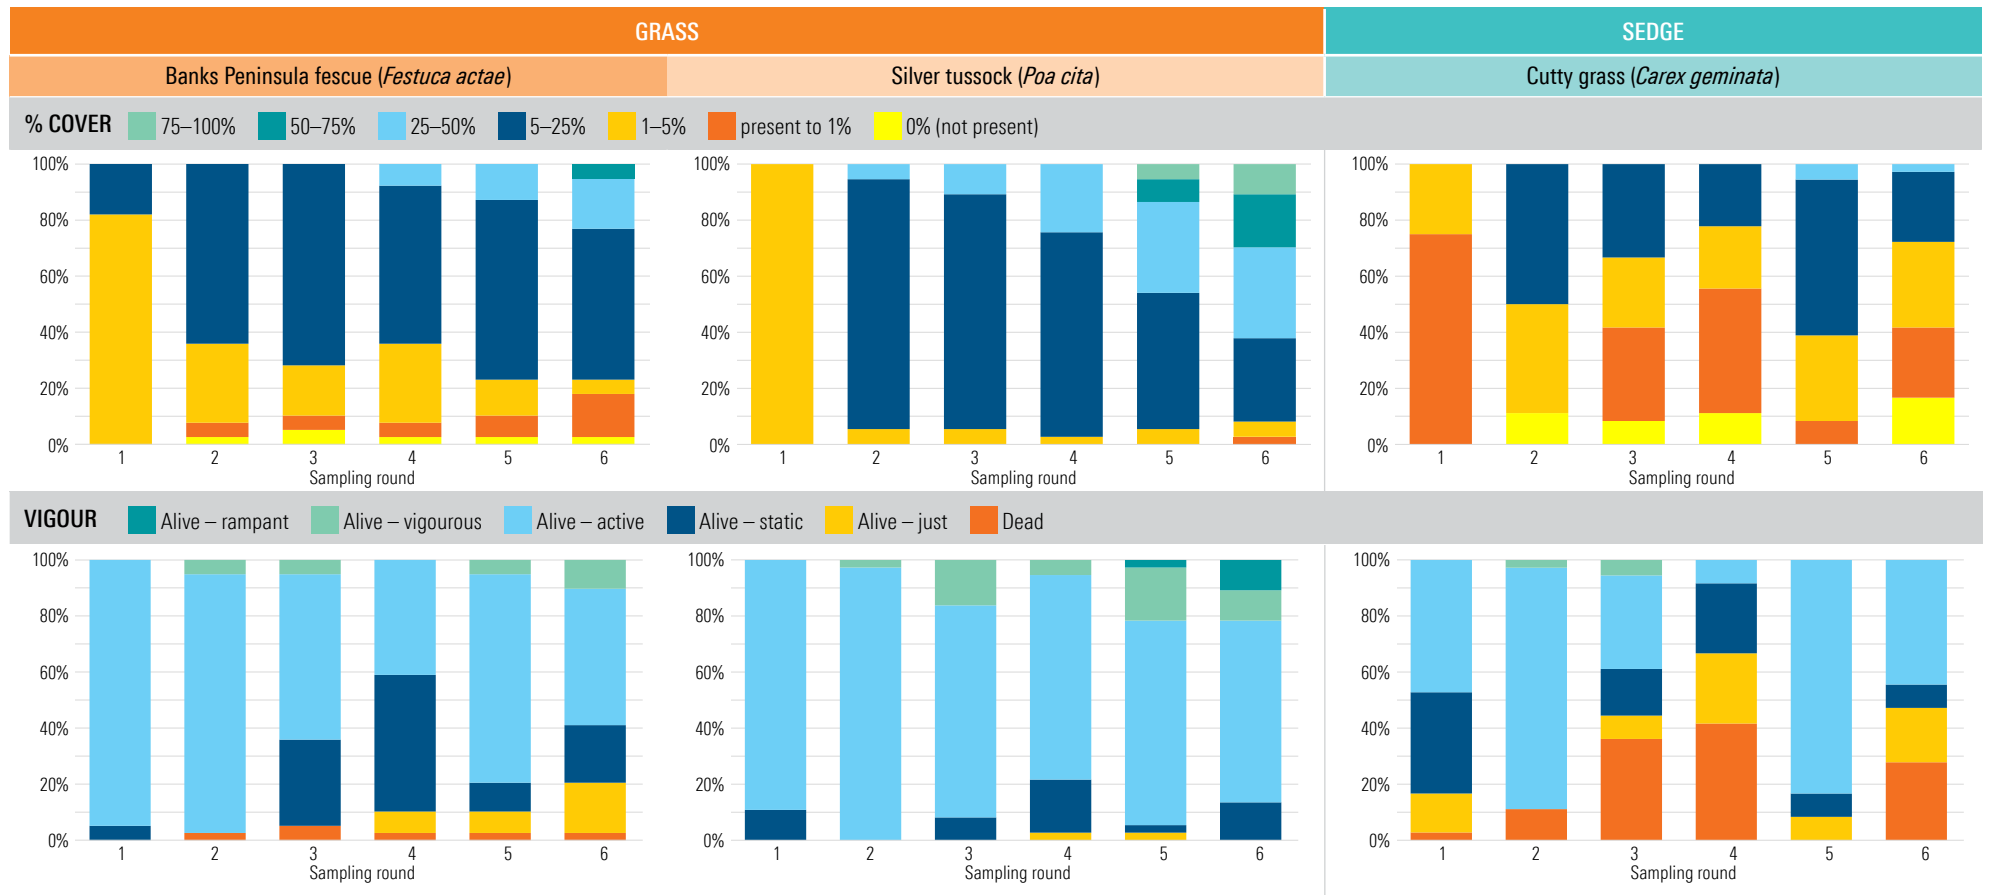
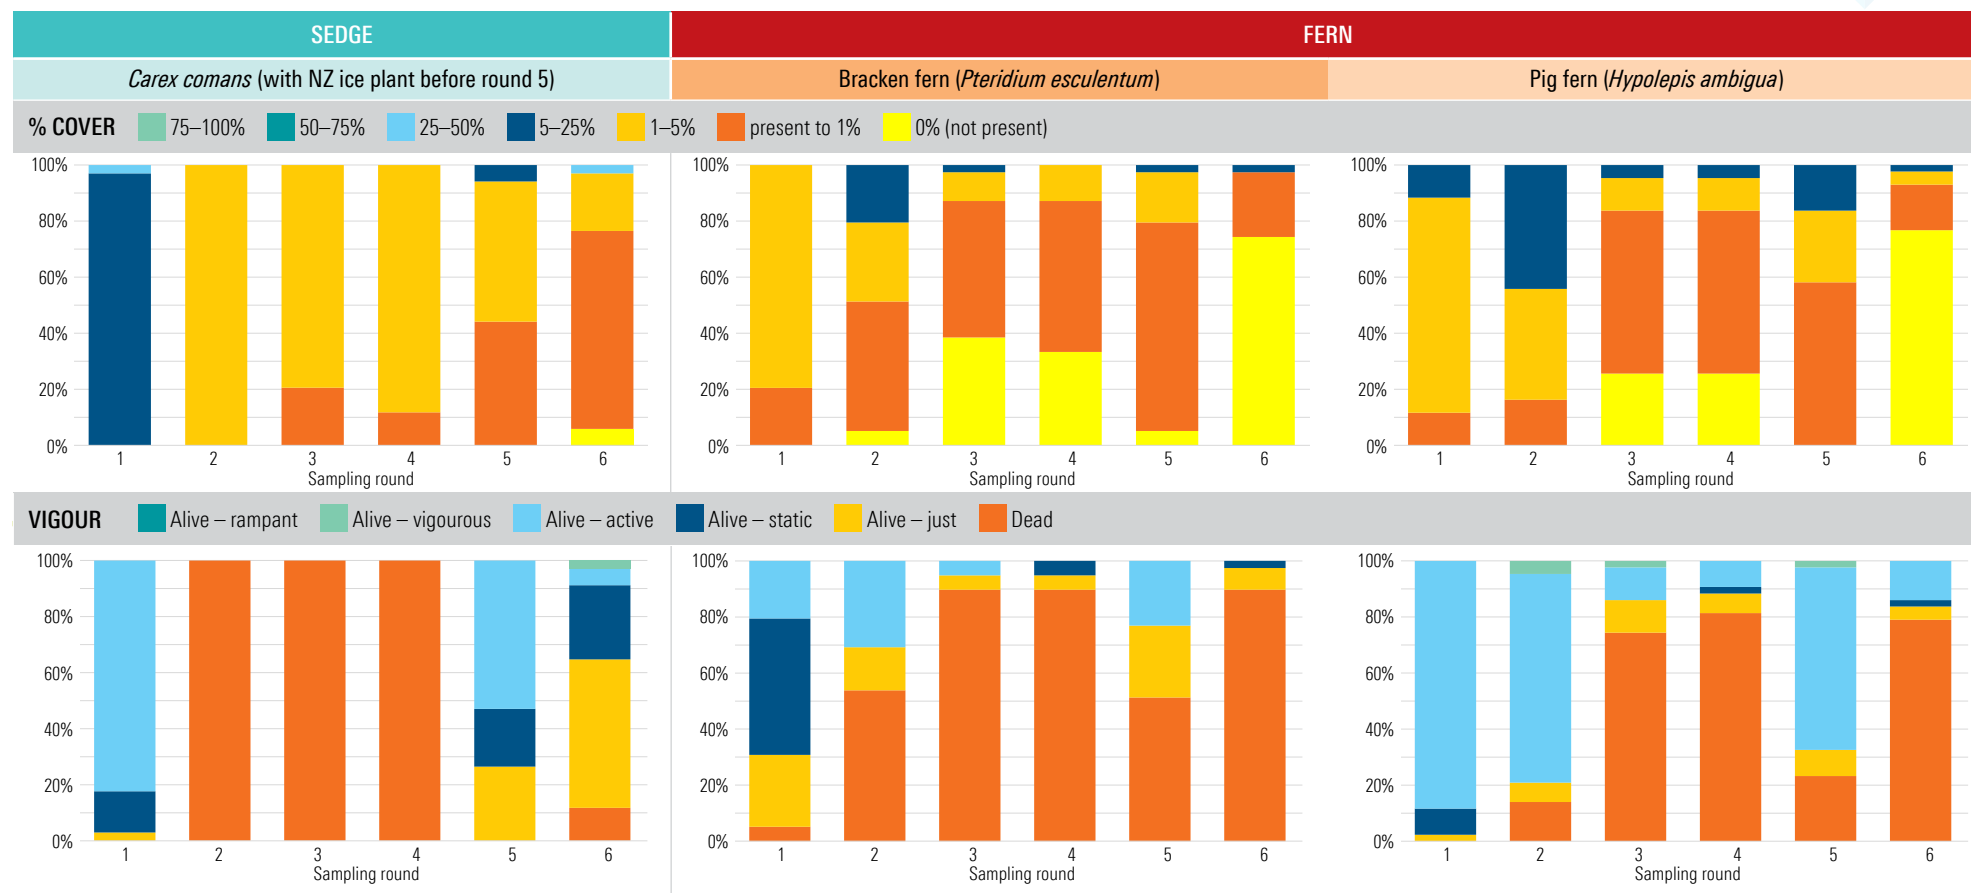
FIGURE 11: Stacked bar graph showing the PERCENTAGE COVER AND PLANT VIGOUR of each plug plant for grids that were classified as 'mainly loess subsoil'. Data is based on the proportion of grids that were classified as one of six cover or vigour categories, and is presented for each monitoring round, undertaken approximately 2, 5, 8, 11, 18 (1.5 years) and 30 months (2.5 years) after site setup. Note that *Carex comans* was planted to replace the dead ice plant (*Disphyma australe*) and dead specimens of *Carex geminata* and the two ferns replaced with new plants between the fourth and fifth monitoring rounds.

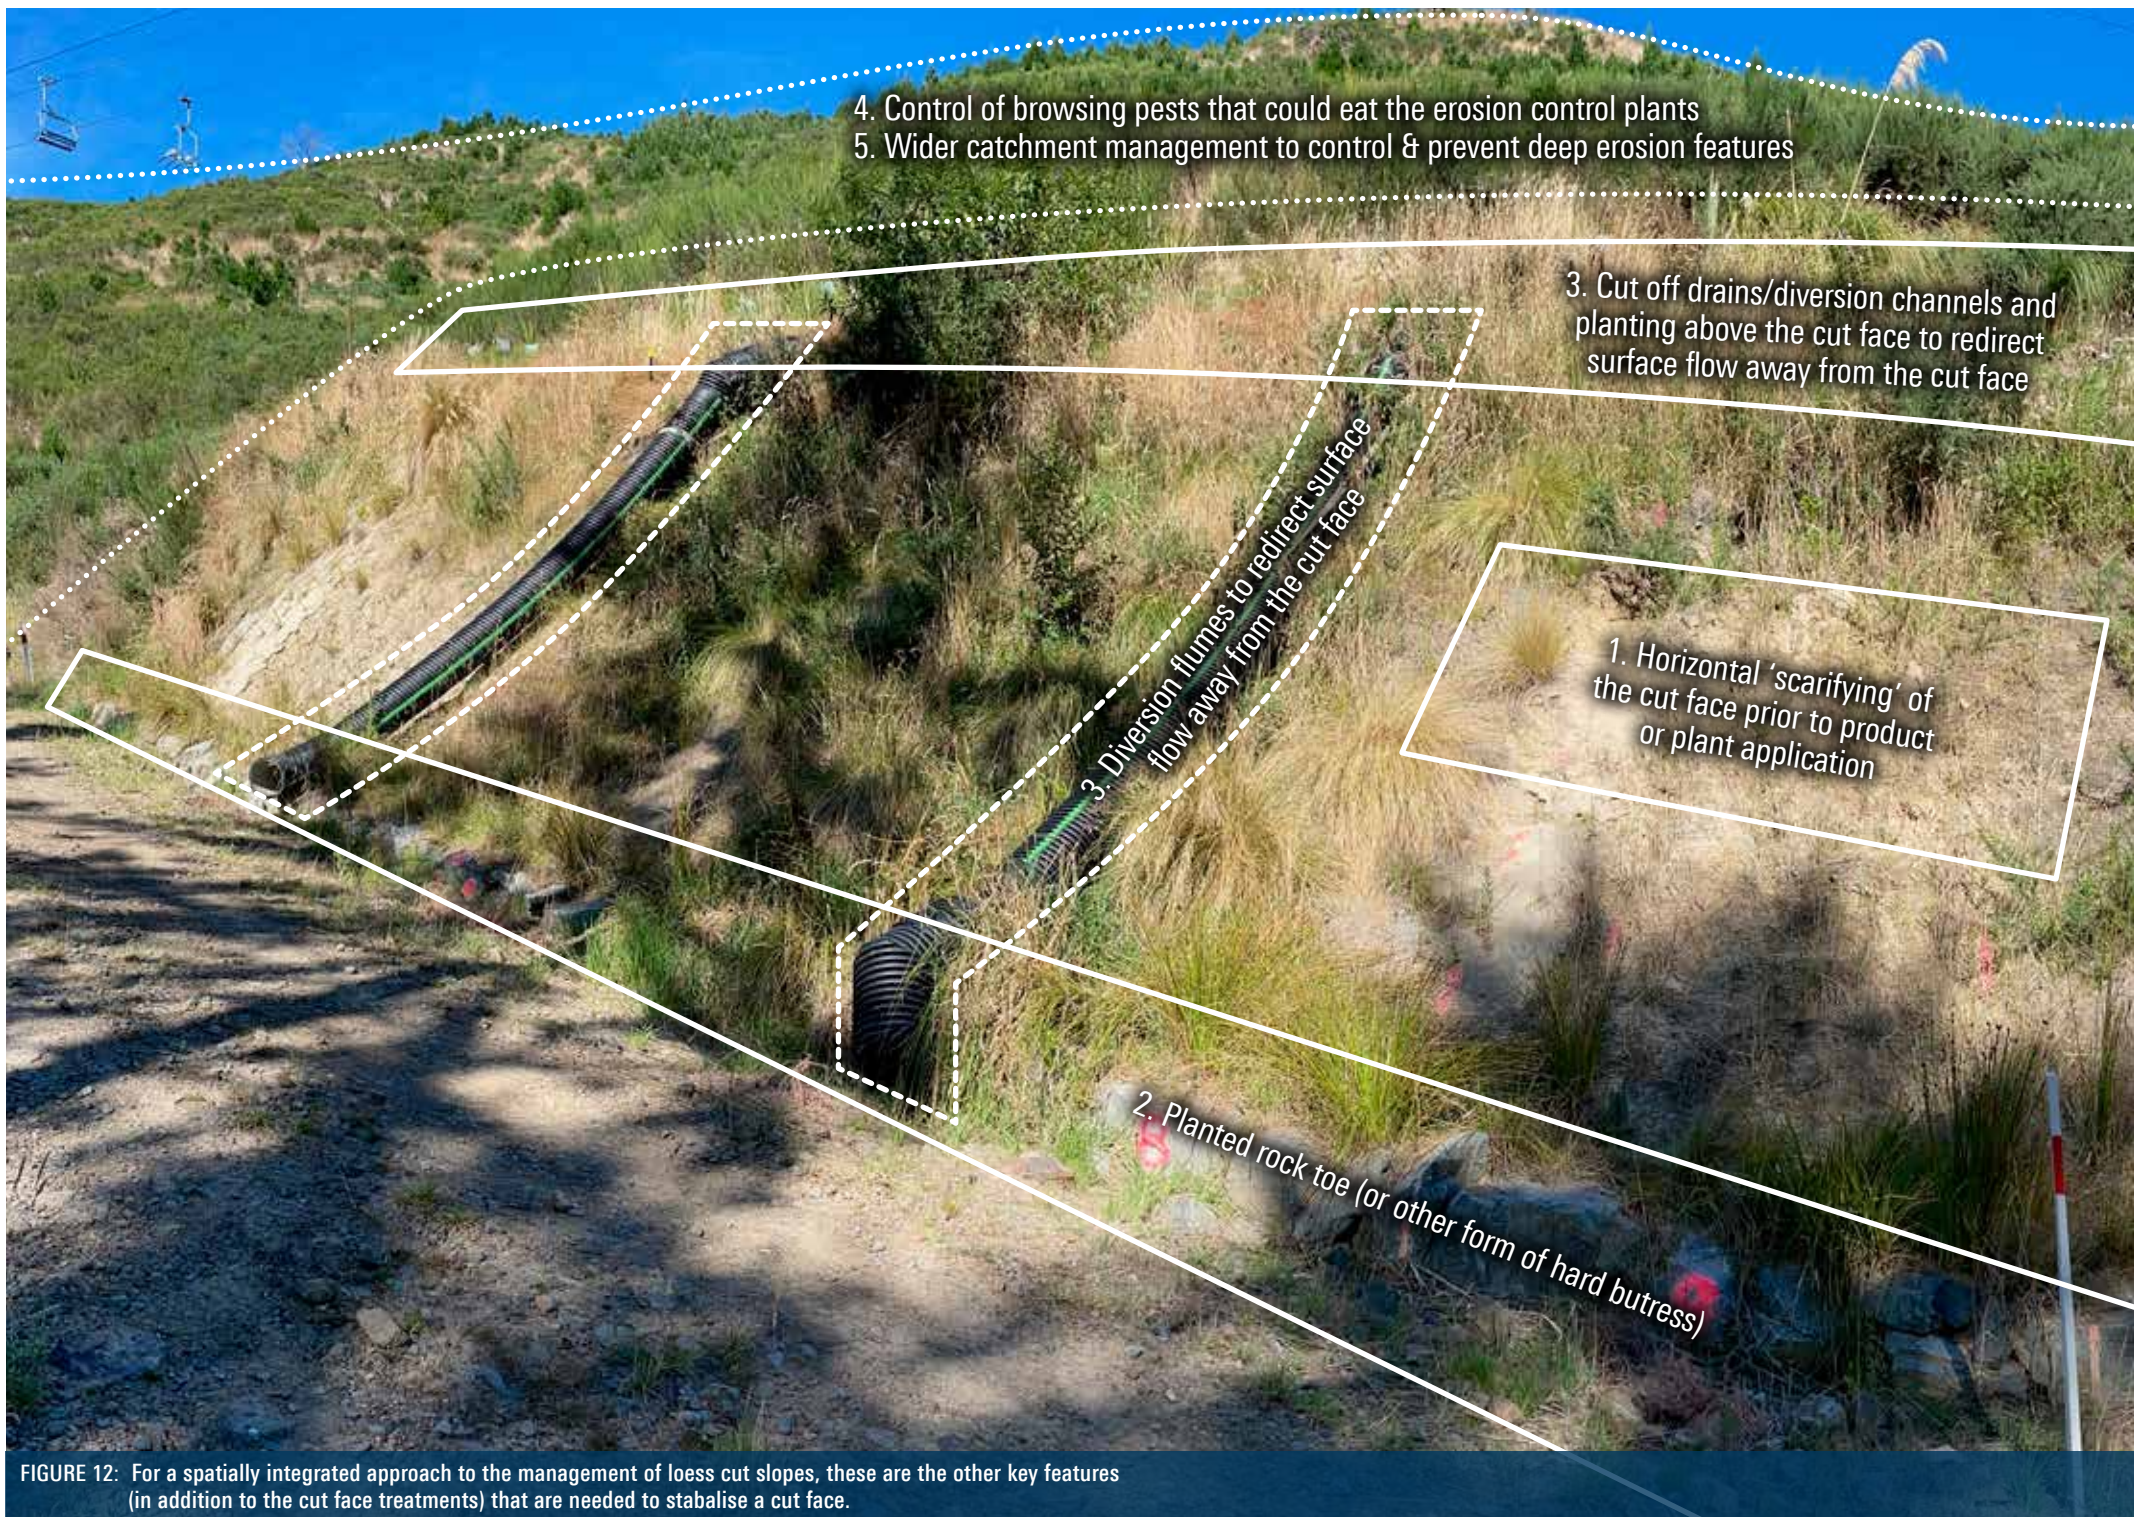
FIGURE 12: For a spatially integrated approach to the management of loess cut slopes, these are the other key features (in addition to the cut face treatments) that are needed to stabilise a cut face.

5. Wider catchment management to control and prevent further deep erosion features (i.e., tunnel gullies and slips that originate above any cut face), which are not able to be controlled through any measures applied on the cut face.

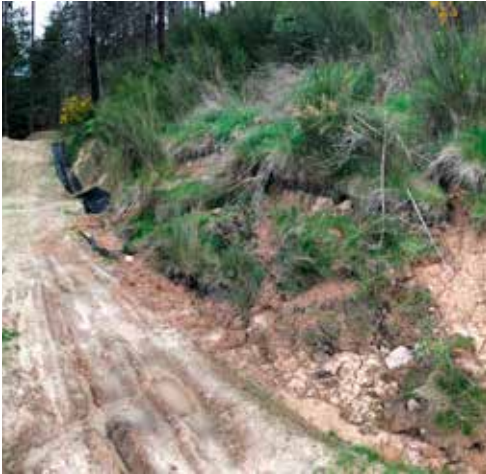
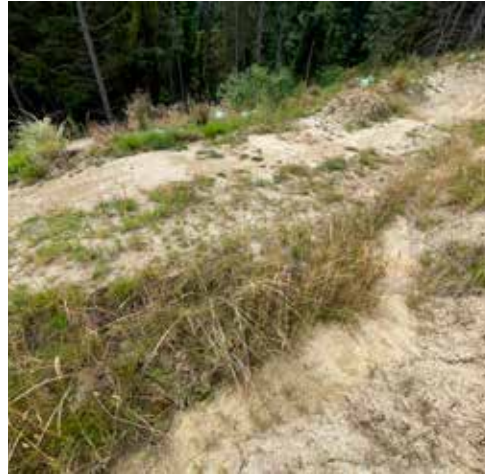
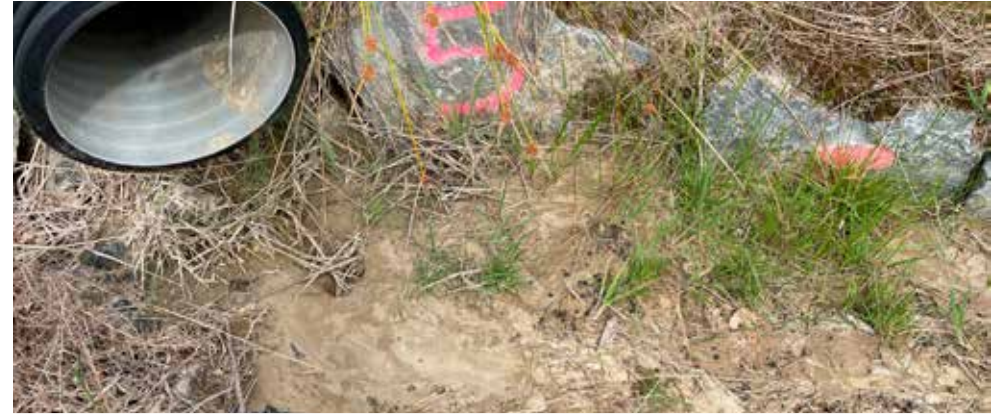
Sediment in the water table for the study site that has come from the diversion flume that takes water from a cut face above the study site.

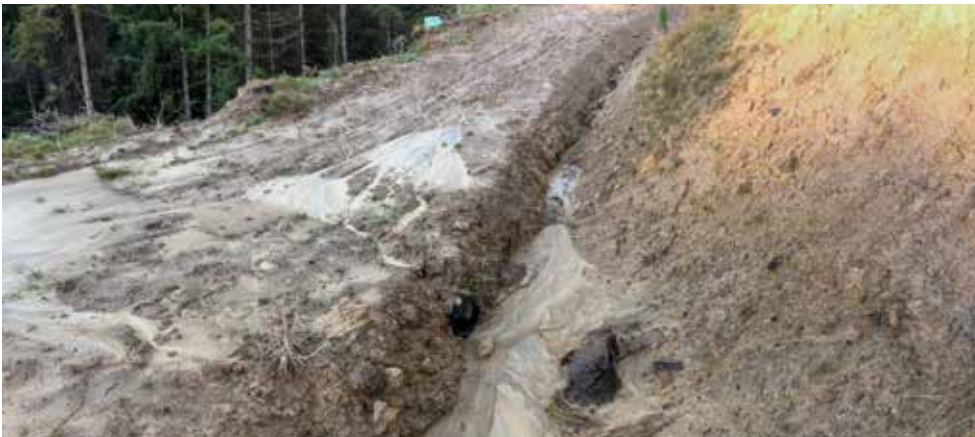
Evidence of erosion and loess runoff from cut faces and track above the study site.

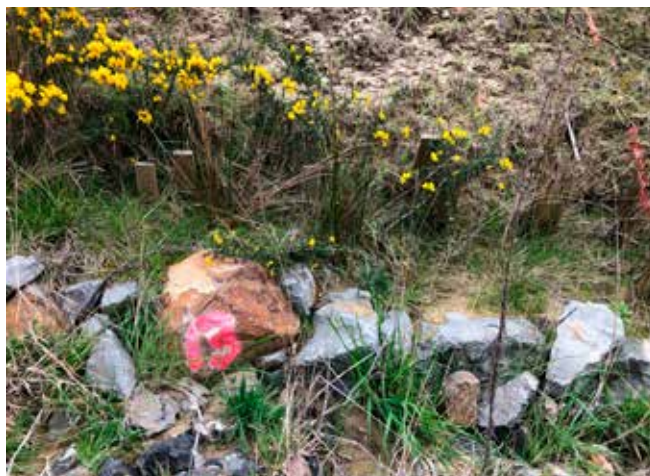
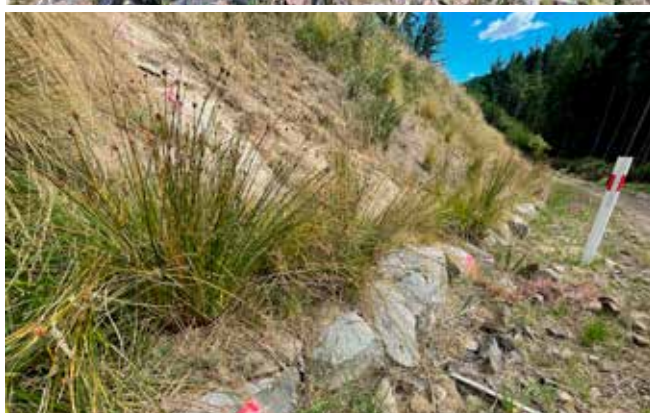
The rock toe in January 2021 showing the established vegetation that is also helping to trap any sediment that does come off the cut face.

Figure 14: Photos illustrating the benefit of having a short flat slope and rock toe at the base of a cut face, as it acts to trap sediment before it can reach the water table.

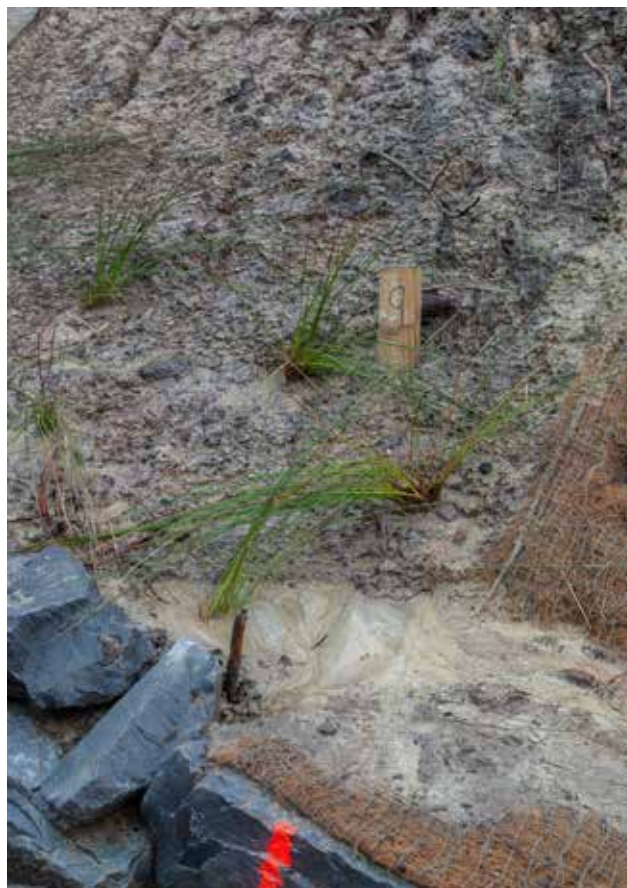
The rock toe in August 2019 showing sediment runoff from Plot 9 (control/no product) being trapped on the rock toe.

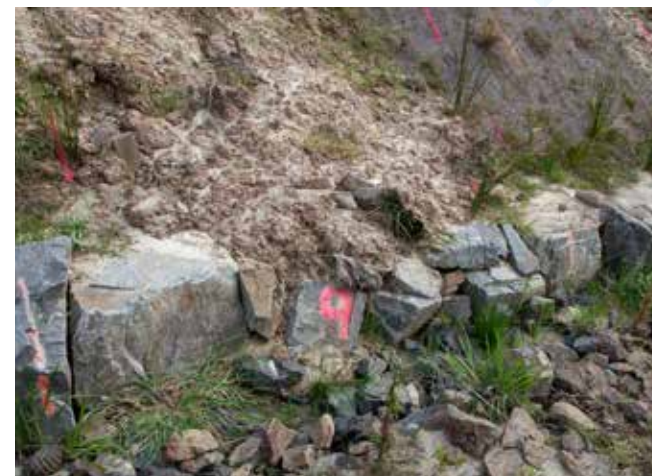
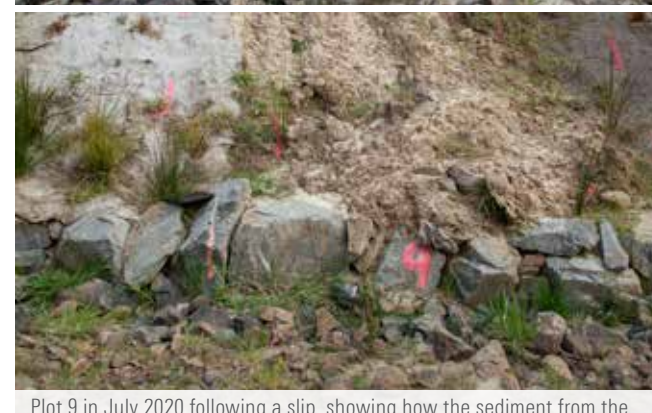
Plot 9 in July 2020 following a slip, showing how the sediment from the slip was retained on the rock toe and kept out of the water table until the material was able to be removed.

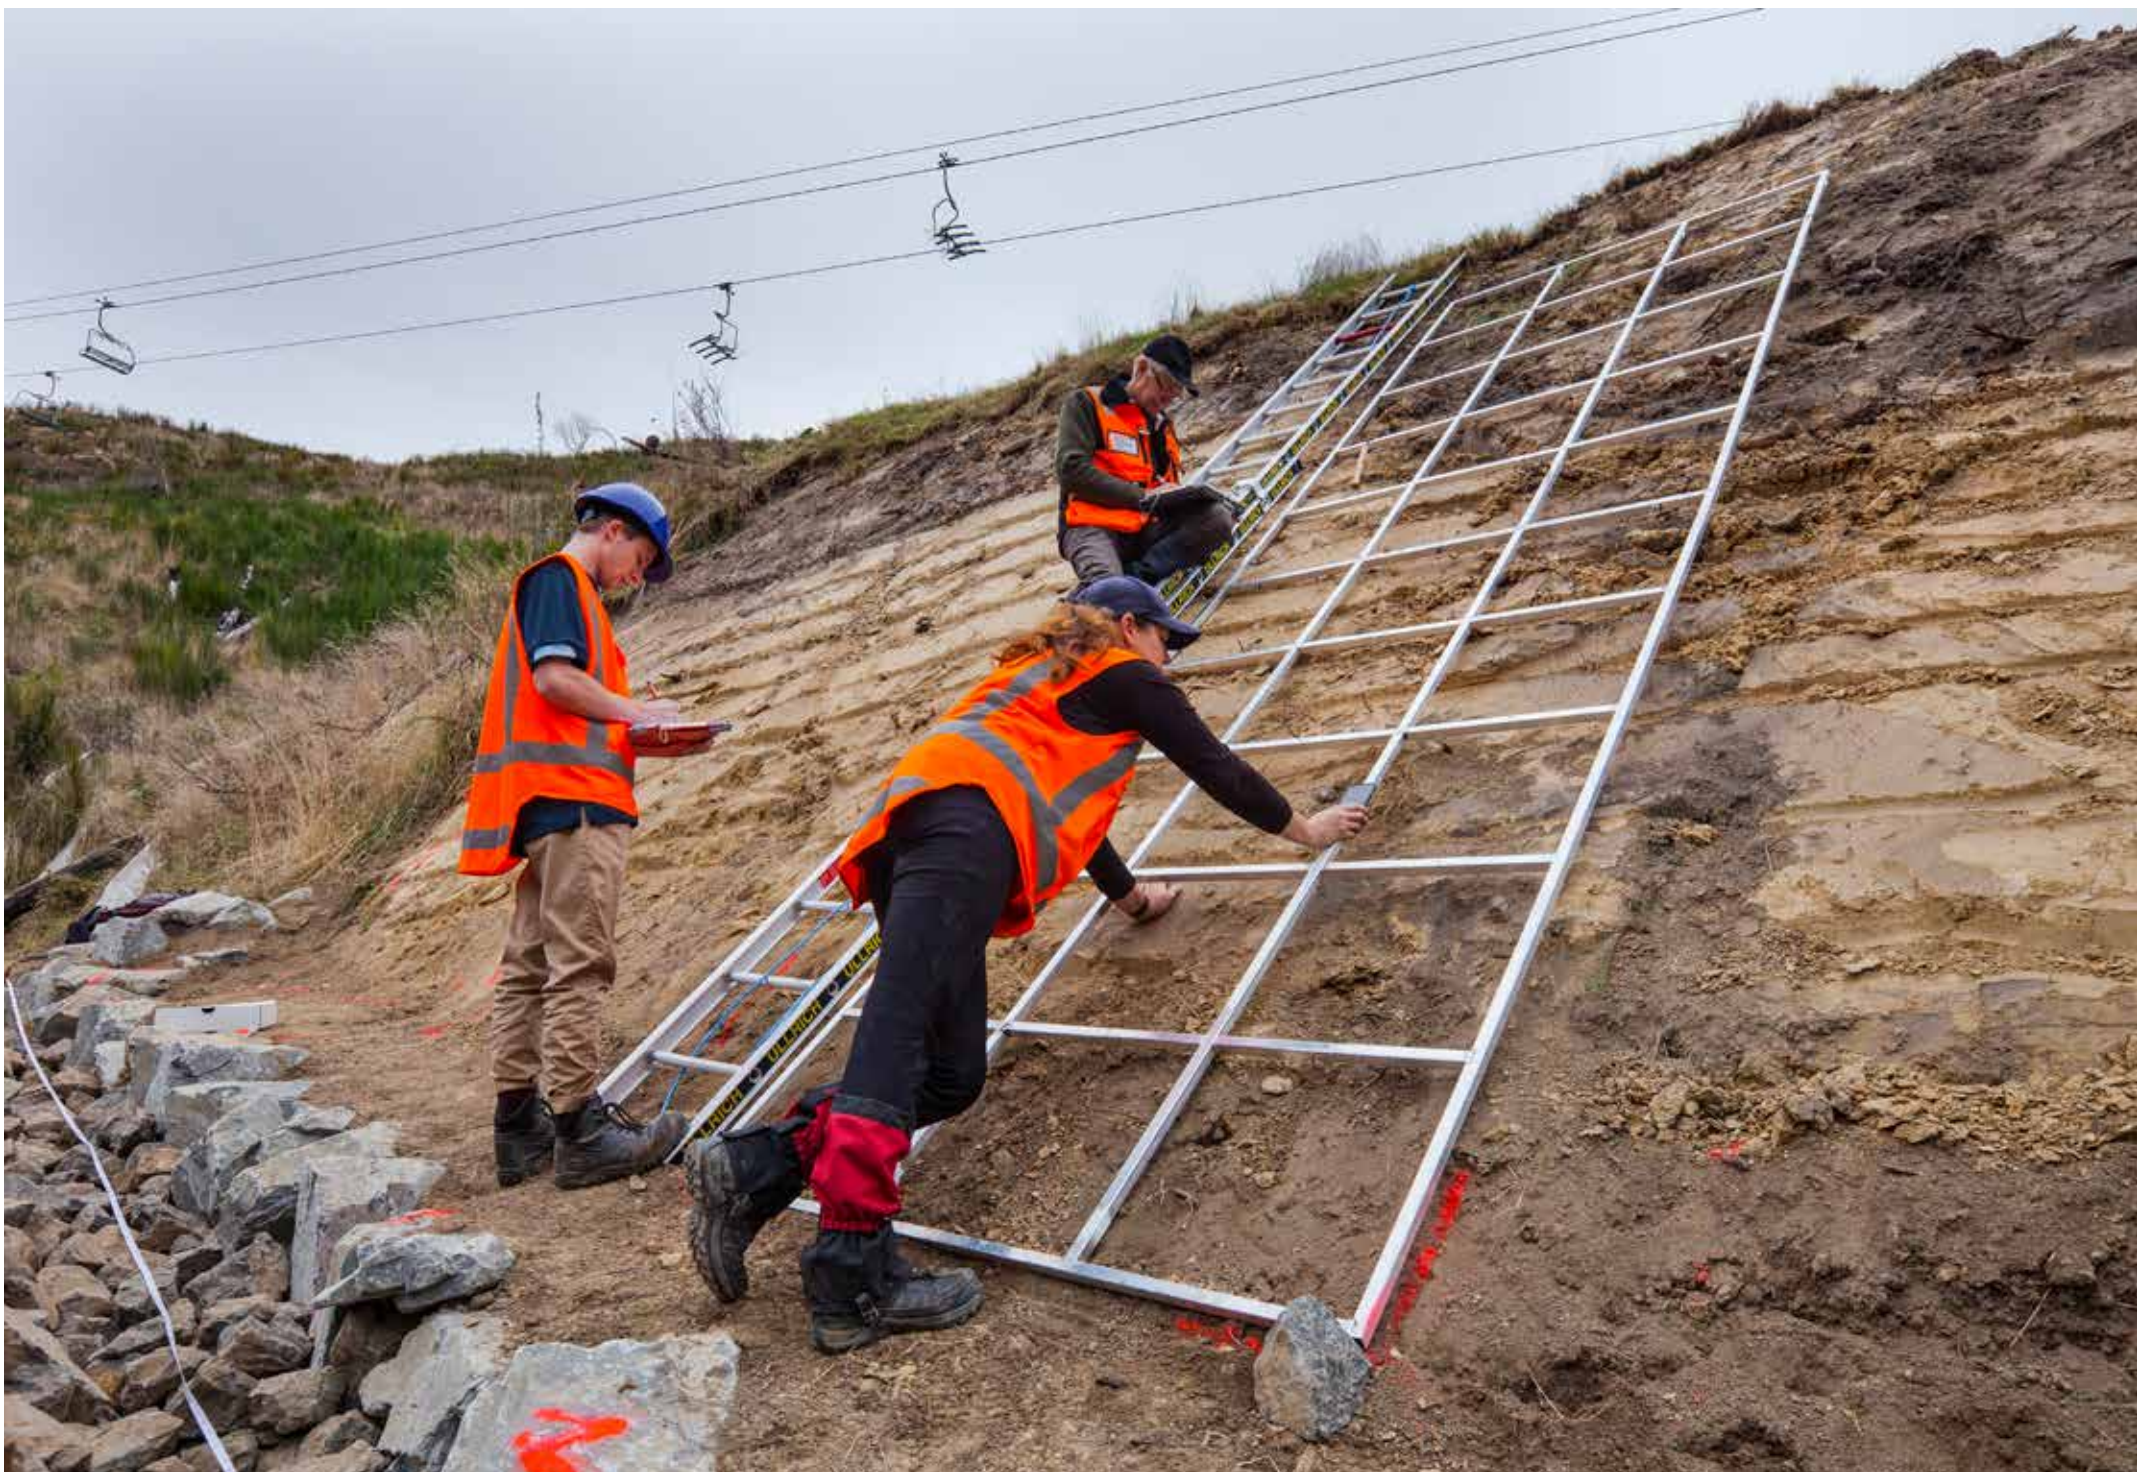
Monitoring soil erosion onsite before planting.
